API Hydro Scheme Pipe Inspection Case Study

API (UK) Ltd

API recently undertook a live pipe inspection project in Scotland on 5.5 km of 400mm PVC/Ductile Iron Hydro Plant pipeline, due to a reduction in hydraulic output identified by the client.

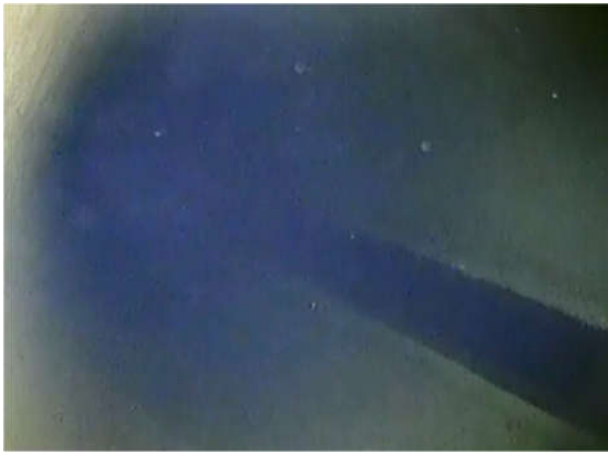
The entire 5.5 km of pipeline was successfully surveyed, with no leaks being identified; however air pockets were identified in 2 sections of pipeline, and also a 50 metre section of pipeline was successfully identified as being imploded due to terrain type and backfill.

Air Pockets Identified

The client installed 2 additional air release valves on the pipeline and exposed the imploded section identified during the live surveys (see images below).

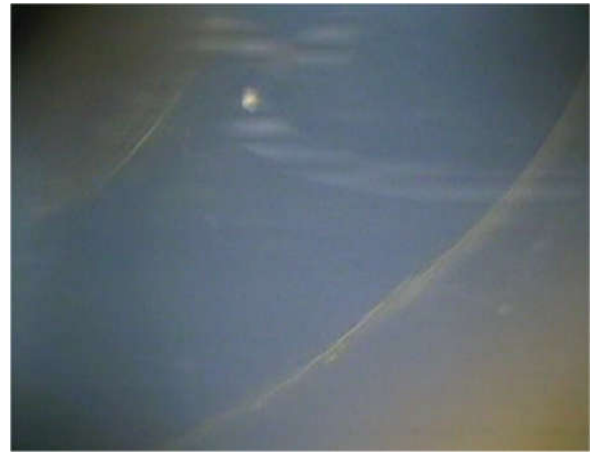
Pipe Implosion Identified

The necessary repairs were undertaken and the pipeline outputs have now returned to the original maximum output levels. The estimated cost of lost revenue due to the reduced hydraulic output is approximately £300 000 per annum.

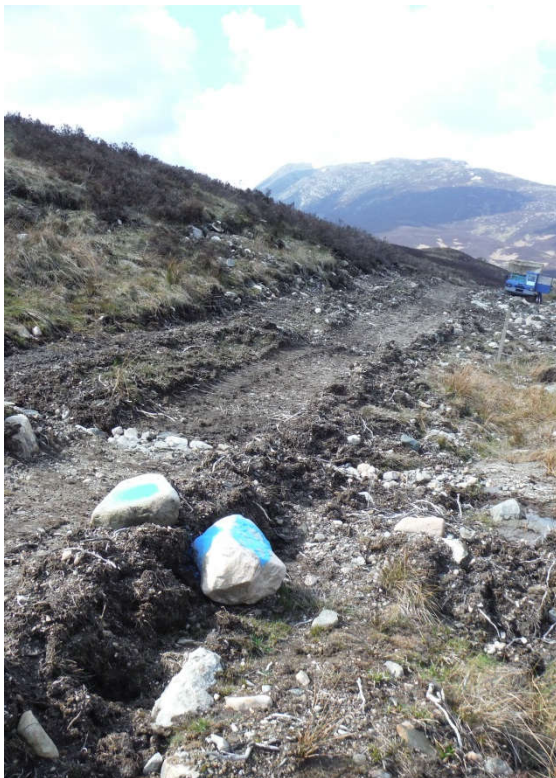
Sensor Traced Above Ground

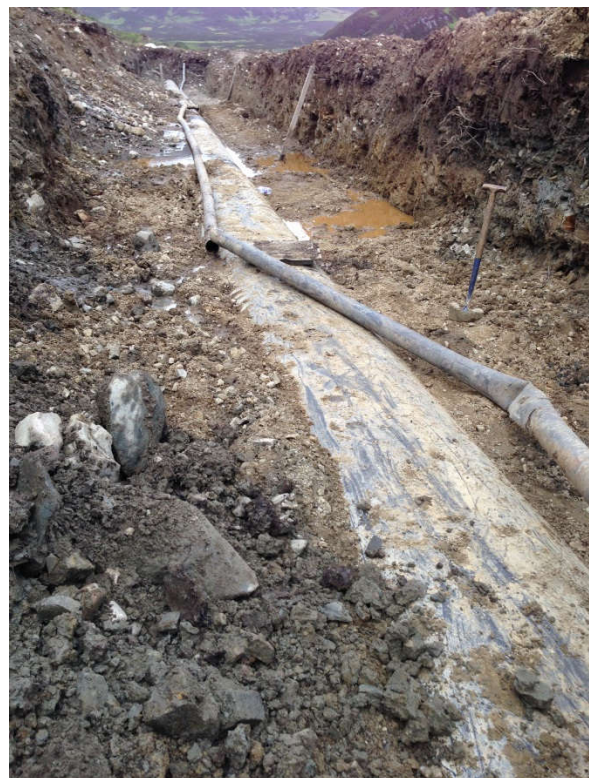
Exposed Imploded Pipeline
