API Live Water Pipe Inspection and Leak Detection

API (UK) Ltd

Scope of Works

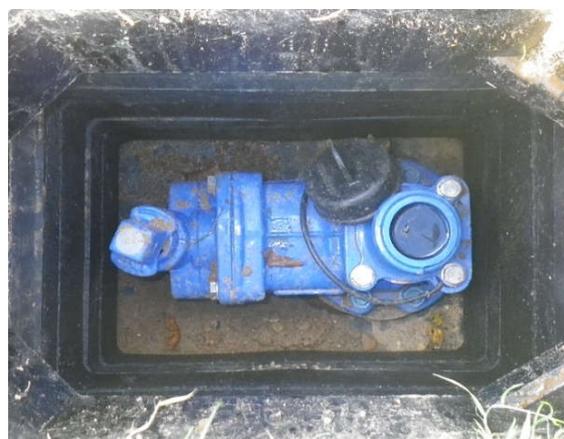
Hydrant (camera entry point)

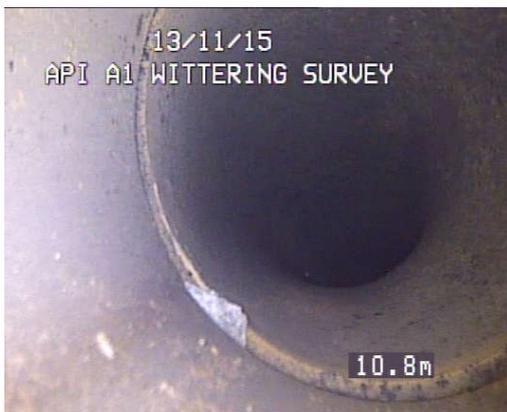
Leak identified on wide joint

- ◆ API successfully identified the leak at 10.8 metres
- ◆ API also identified an additional leak at 50 metres (all were later validated by client)
- ◆ A non-known in line valve was identified (see image above)
- ◆ Tethered insertion technology system allowed for precise location of the leaks to be identified
- ◆ Acoustic system is very sensitive and able to pick up small and large leaks
- ◆ Operator was able to identify multiple leaks in close proximity to each other

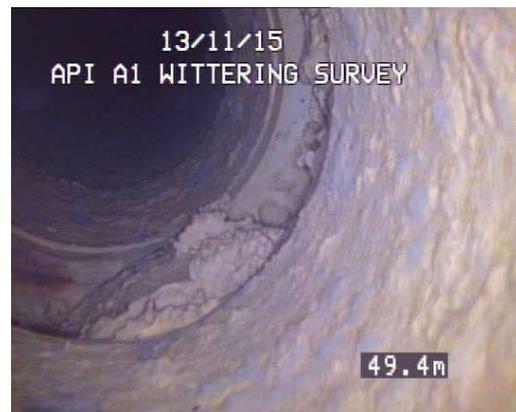
Buried valve identified
