API Live Water Pipe Inspection and Leak Detection Large Diameter

API (UK) Ltd

Scope of Works

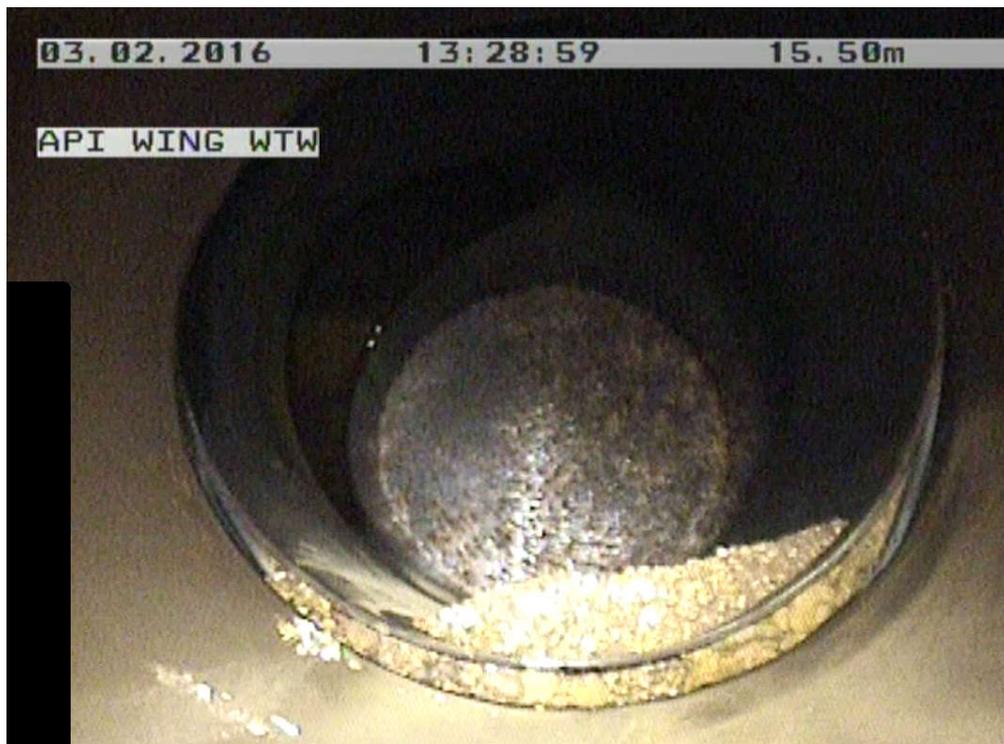
Leak identified on wide open joint section with debris ingress identified

- ◆ API successfully identified the leak at 15.5 metres
- ◆ Tethered insertion technology system allowed for precise location of the leaks to be identified
- ◆ Acoustic system is very sensitive and able to pick up small and large leaks
- ◆ Operator was able to identify no other leaks with joints identified in close proximity to each other

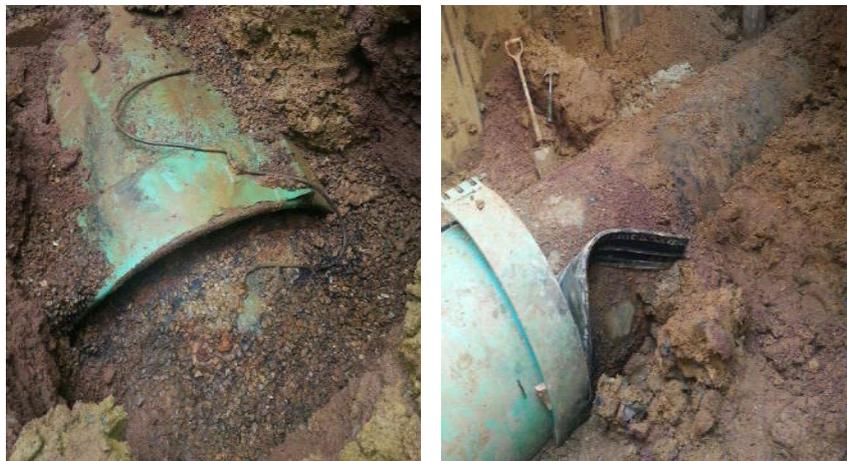
Leaking joint identified
