## **Advanced Pipe Inspection (UK) Ltd**

**NDT Testing report produced on behalf of:  
SAMPLE REPORT**

# NDT Pipe Inspection Report

### API-RED COW DMA CRACKED PIPE SECTION

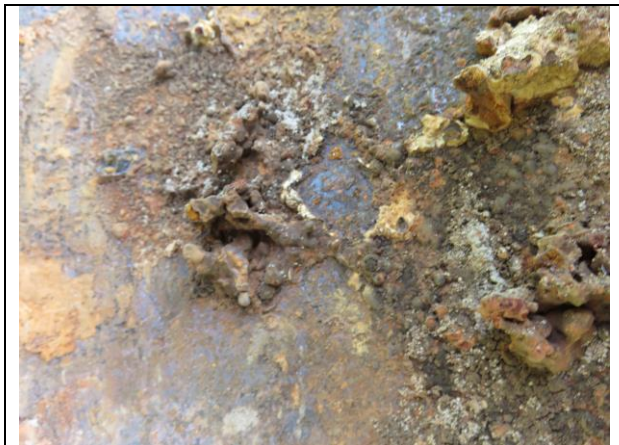
**Title 1**

Pipe wall image tuberculation identified

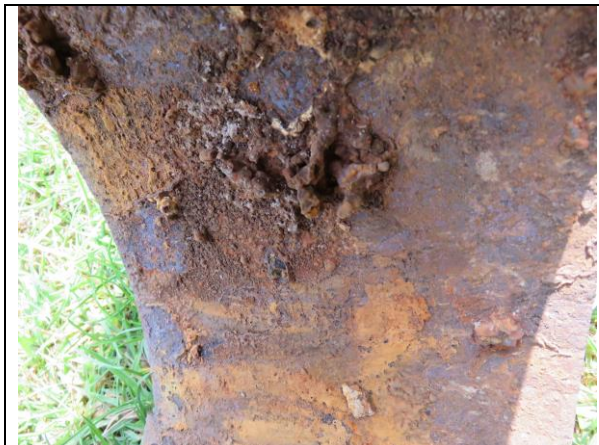
**Title 2**

Pipe wall image tuberculation identified

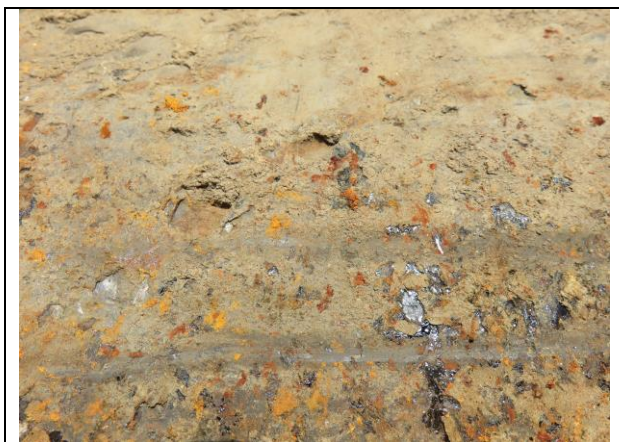
**Title 5**

Pipe wall image pitting

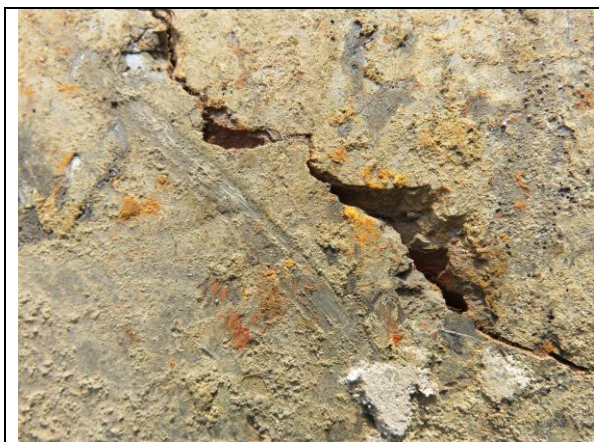
**Title 6**

Pipe wall image fracture

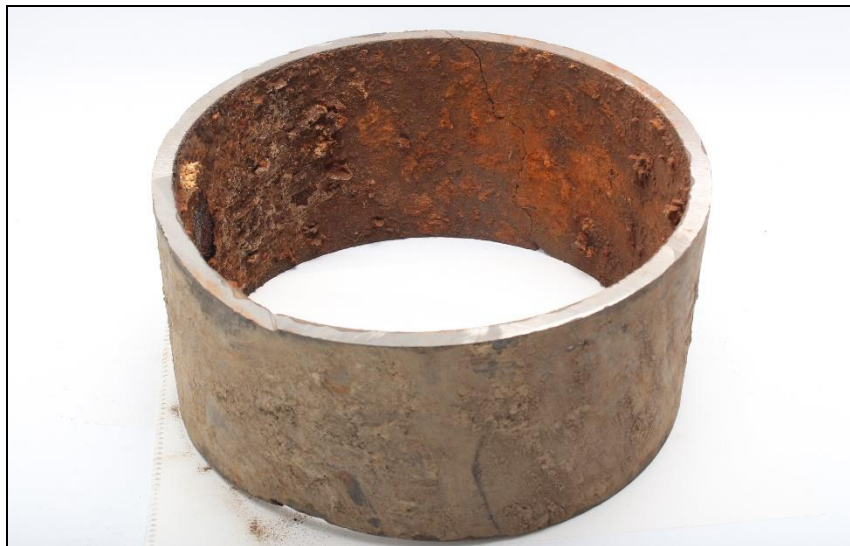
The sample can be seen in its as received condition in figure 1.

*Figure 1: The pipe as received.*

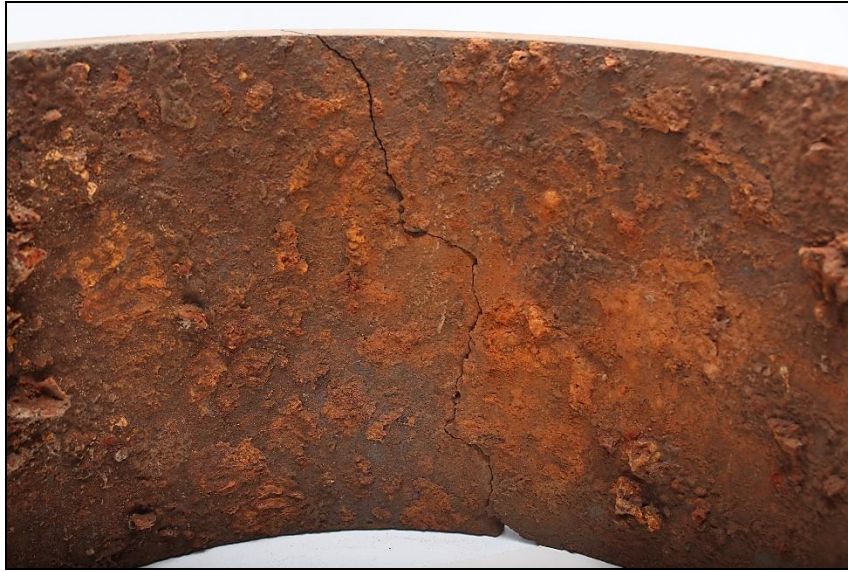
The crack (figure 2) was sectioned from the pipe section and cleaned using a 30% hydrochloric acid in water solution. This removed the surface contamination and enhanced the fractographic features that had not been compromised by corrosion.

*Figure 2: The main crack through the section of pipe provided.*

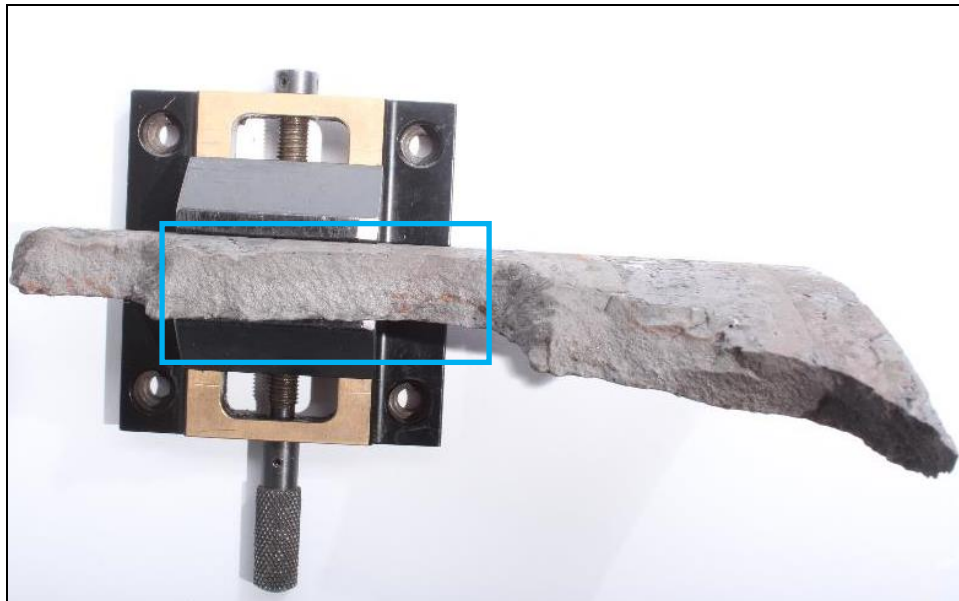
The crack face was examined under the stereo microscope at magnifications up to X40. This showed no indication of areas of fracture initiation. A macroscopic examination (figure 3) shows the portion of the fracture provided to have failed in a brittle manner.

*Figure 3 (a): The cleaned crack face.*

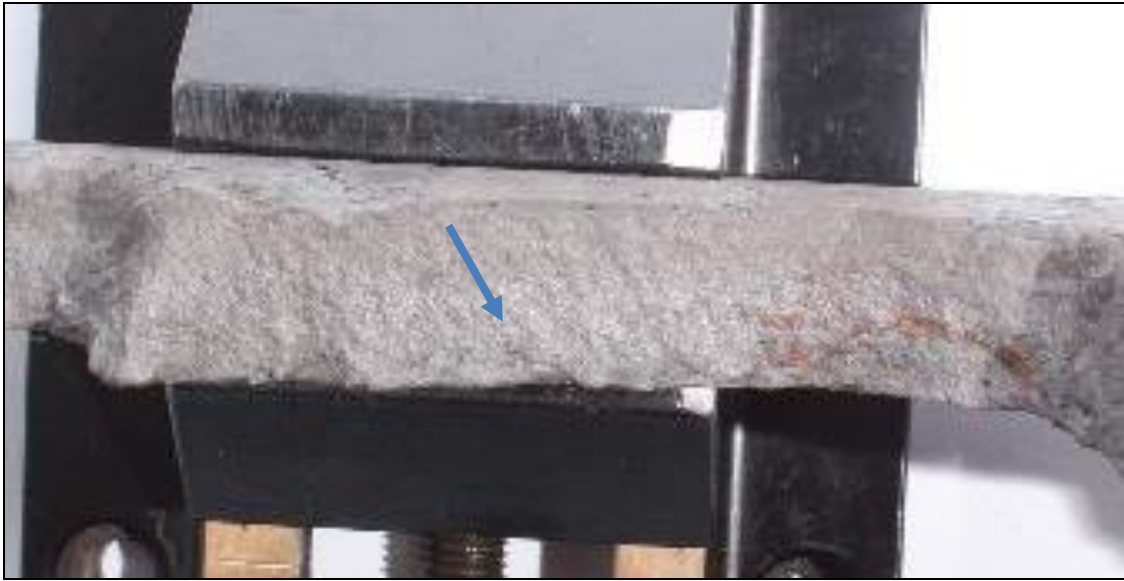
The section provided appears to have fractured from the external surface in a brittle manner. The changes in fracture path indicated multiple crack initiation points with coalescence of the advancing crack fronts into one major crack.

*Figure 3 (b): Expanded area gathered from Figure 3 (a) displaying the direction of crack propagation.*

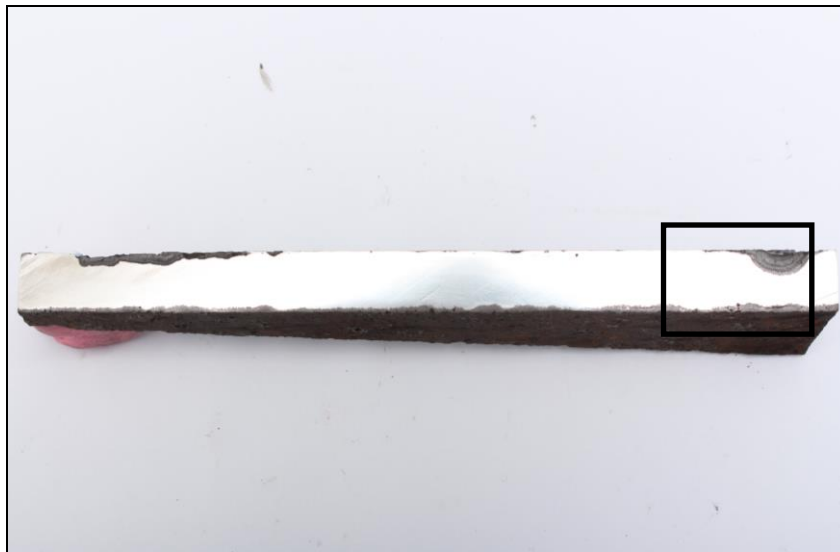
A cross section was taken through the entire width of the pipe wall to assess oxide thickness (figure 4). This showed a relatively even depth of oxide on the internal surfaces of nominally 1.5mm. The external surface shows a consistent layer of oxide as well as deep pits which have considerably reduced the pipe

*Figure 4: A cross section of the entire pipe width provided.*

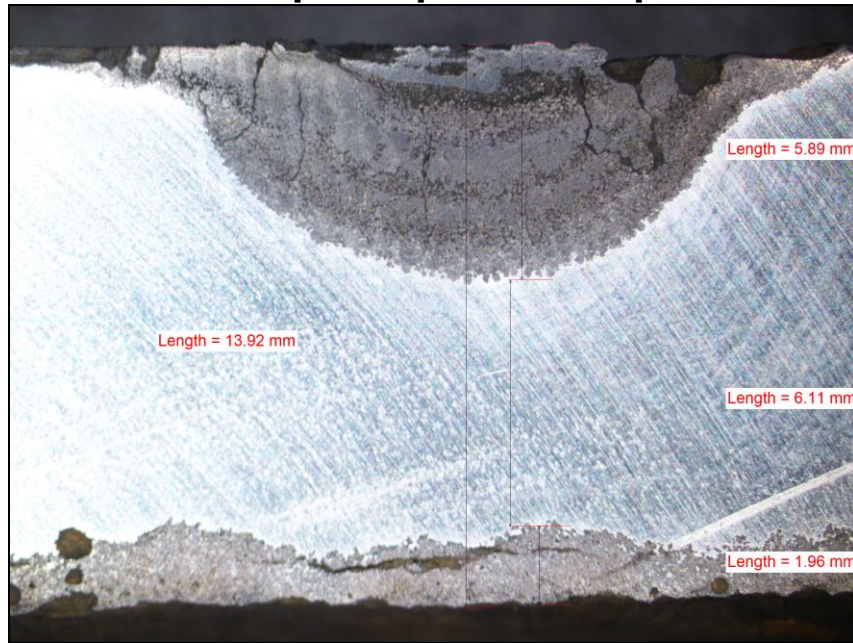
wall thickness a portion of the cross section showed the wall thickness to have been reduced to 6mm (figure 5)

*Figure 5: Macroscopic image of the area shown in figure 4 with most wall thickness reduction. Image taken at X6.*

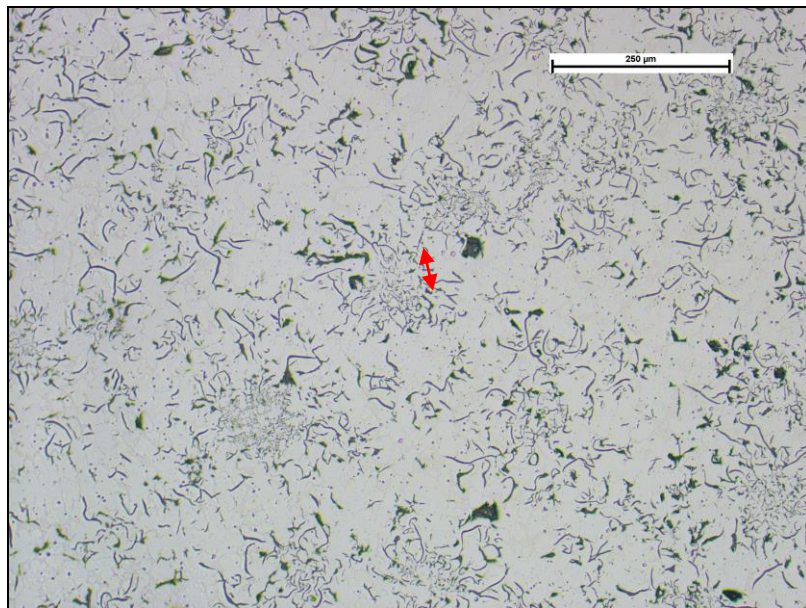
A portion of an area highlighted in figure 3 (a) was sectioned from the crack and mounted in phenolic resin and successively ground and polished to a 1-micron finish. The examination revealed a grey iron flake structure with a type B rosette form (figure 6). The sample was etched in 2% nitric acid in methanol to reveal the microstructure. This revealed a predominantly ferritic structure with a phosphide eutectic phase. This material is typical of centrifugally cast iron (figure 7).

*Figure 6: As polished sample displaying type B graphite. Image taken at X100.*

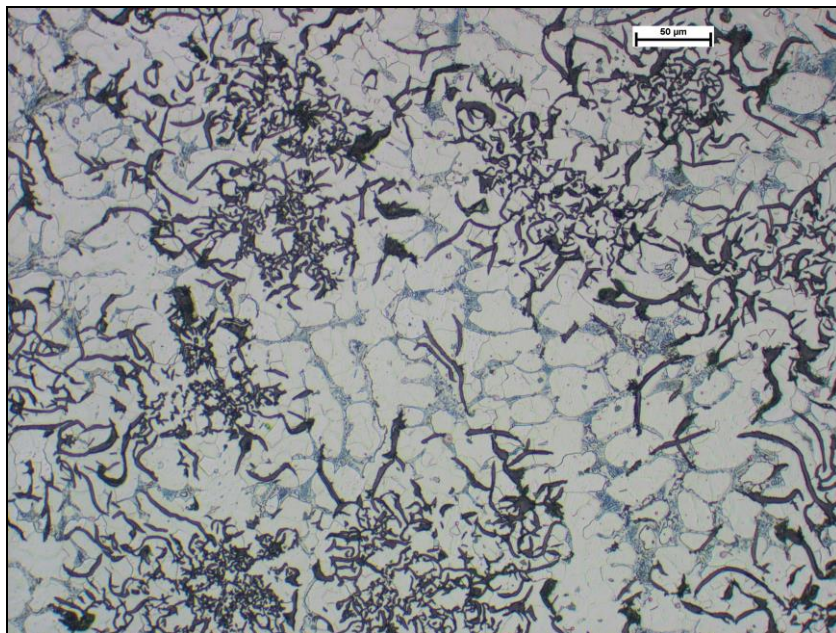
The microstructure exhibited phosphide eutectic, not uncommon in spun-cast pipes, which increases the hardness of the material, but also the degree of brittleness. It may therefore, have contributed in some small way to the fracture, although the localised reduction in wall thickness from corrosion, and the flake graphite in the structure, which is inherently brittle were considered to be the dominant factors in the fracture. The source of the loading to cause fracture could not be established from examination of the supplied sample.

*Figure 7 (a): Photomicrograph displaying ferrite grains, graphite flakes, and phosphide eutectic. Image taken at X200.*

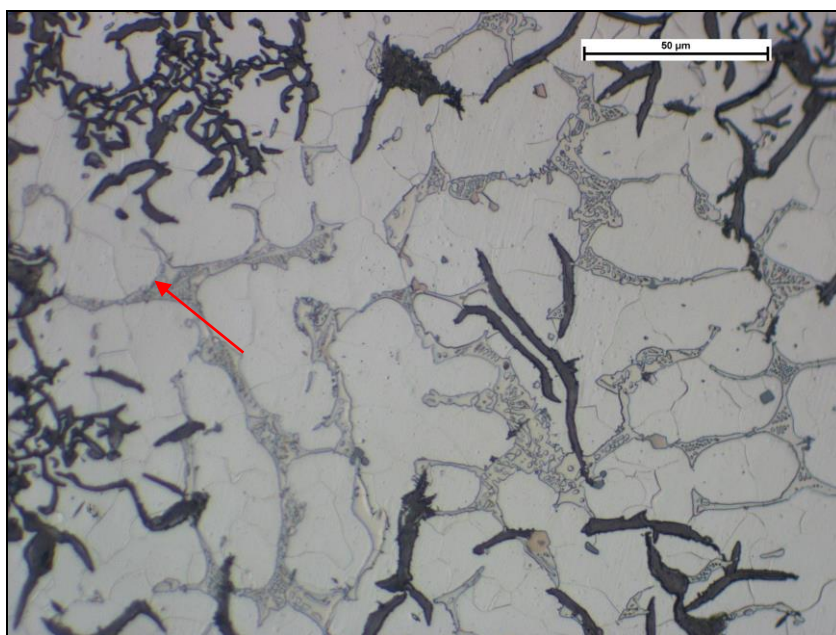
*Figure 7 (b): Photomicrograph displaying ferrite grains and phosphide eutectic (arrowed). Image taken at X500.*
