## **Pipe Assessment Report**

**CCTV Inspection report produced on behalf of:  
SAMPLE**

A pressurised CCTV survey was undertaken on a potable water pipeline to confirm internal pipe condition as part of a zonal study investigation scheme. All inspections were undertaken via existing type 2 fire hydrants using PIPA Technology approved for use in potable water mains.

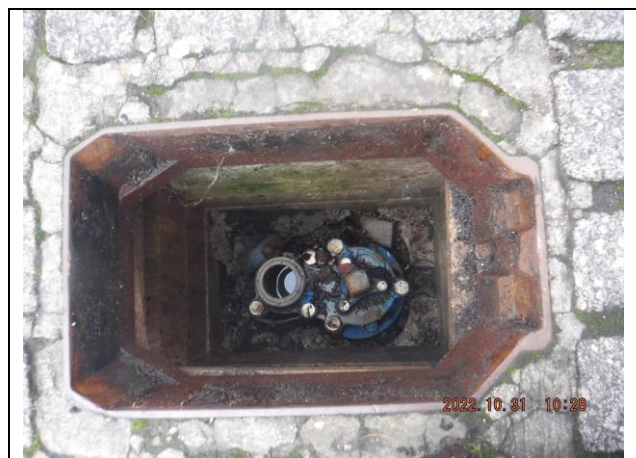
Camera insertion point hydrant

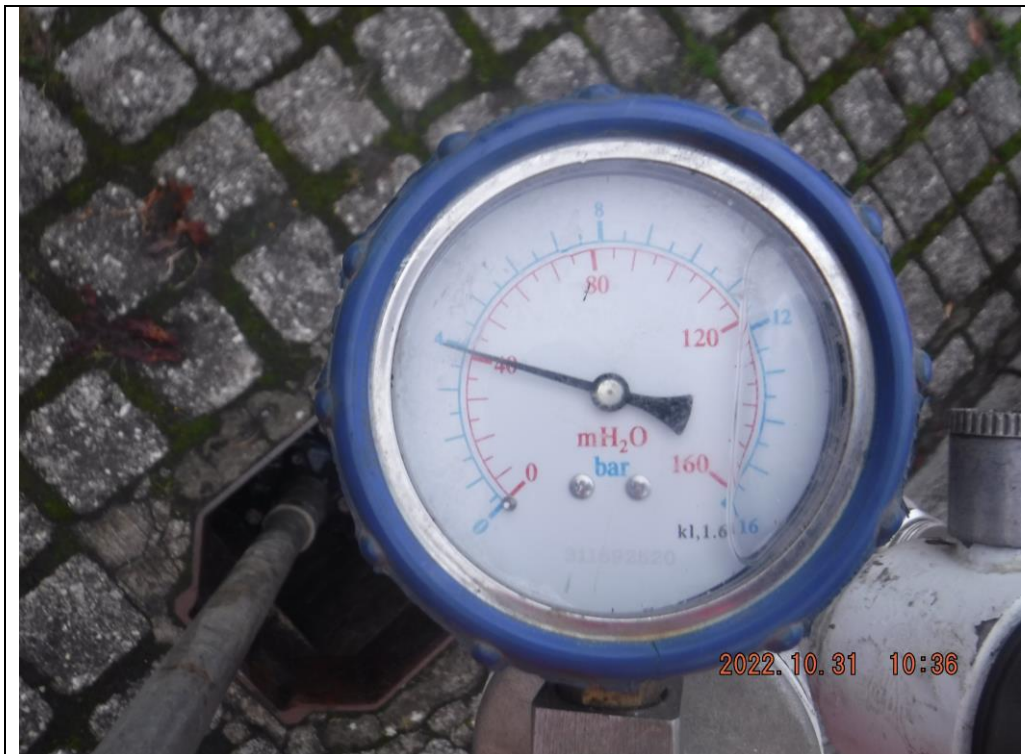
Pressure reading taken on site (actual):

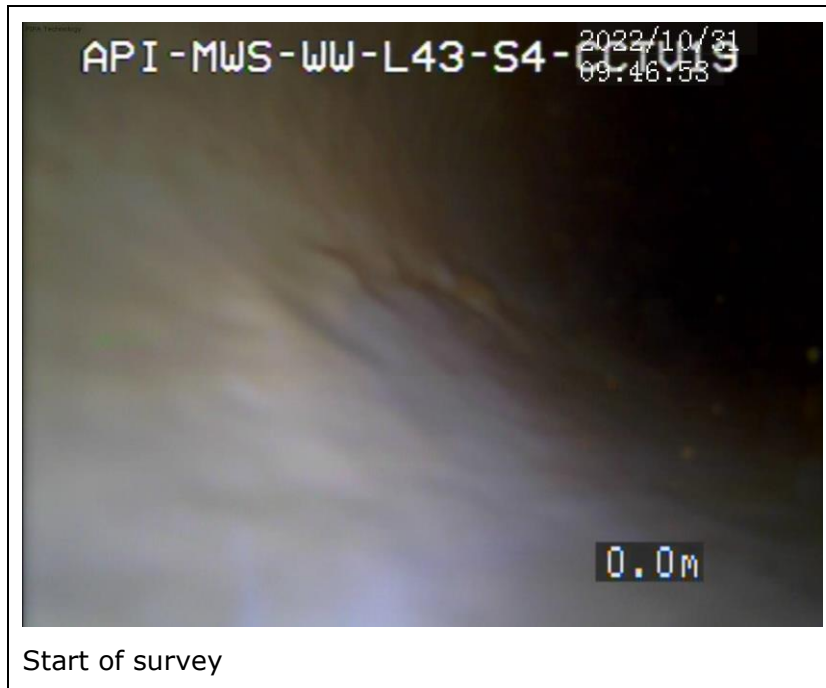
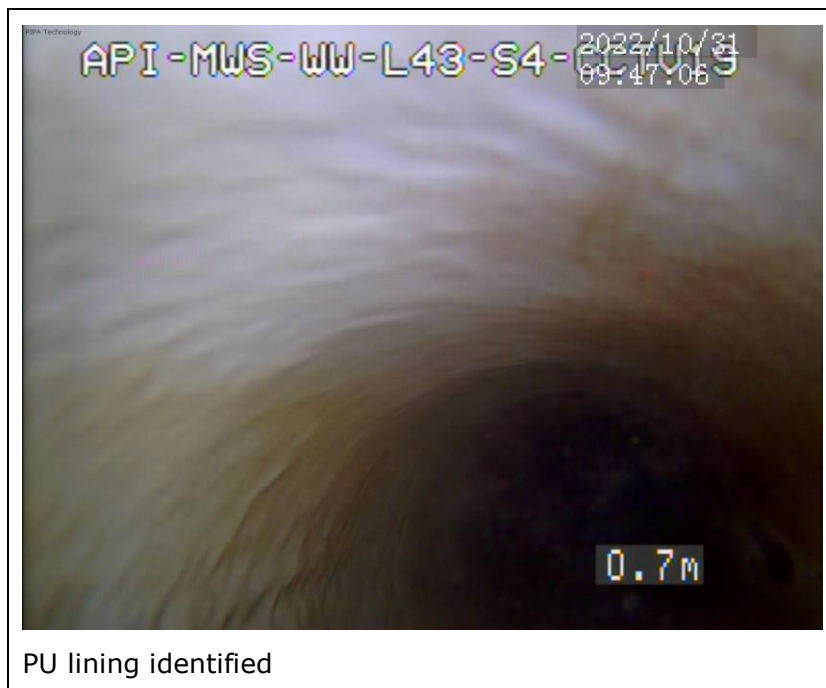
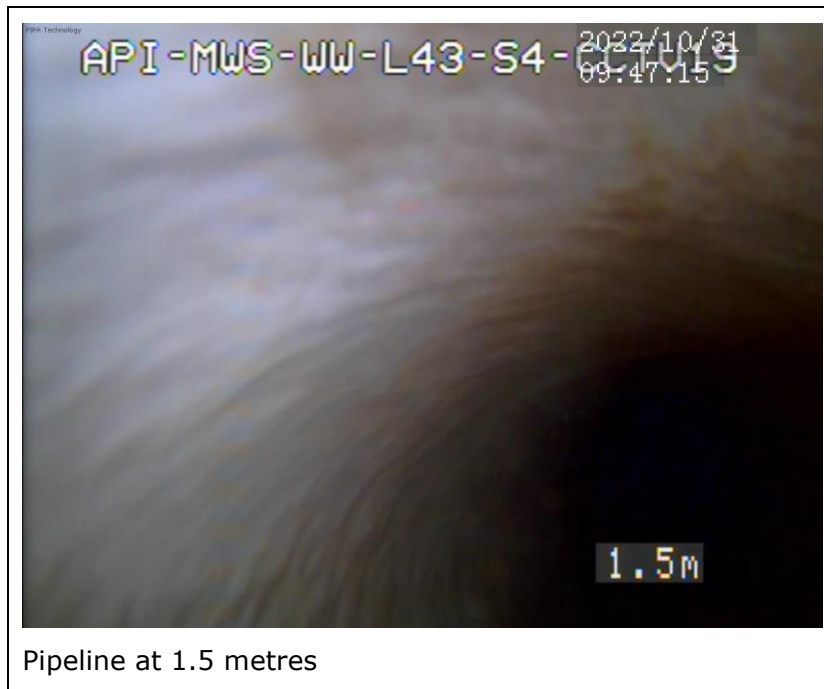
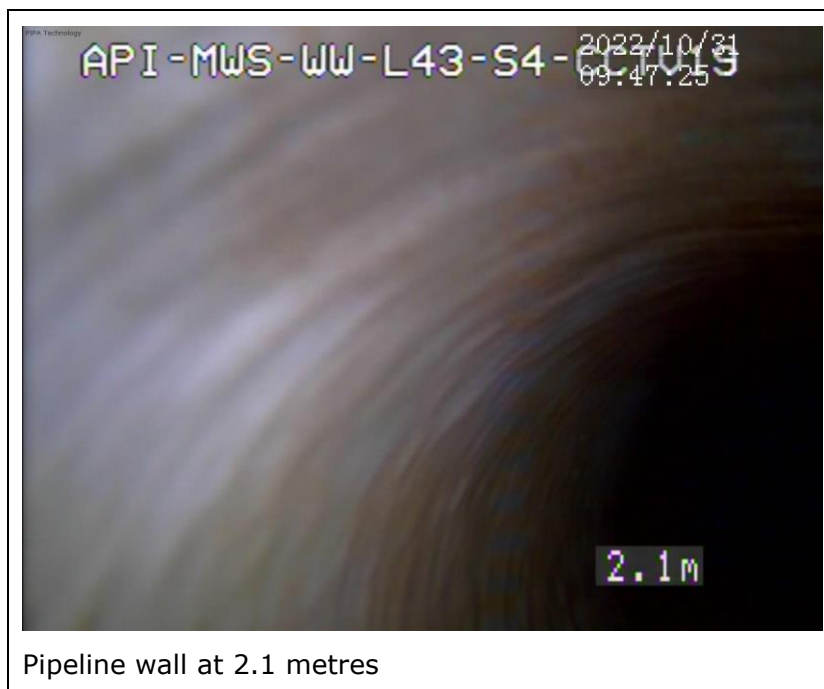
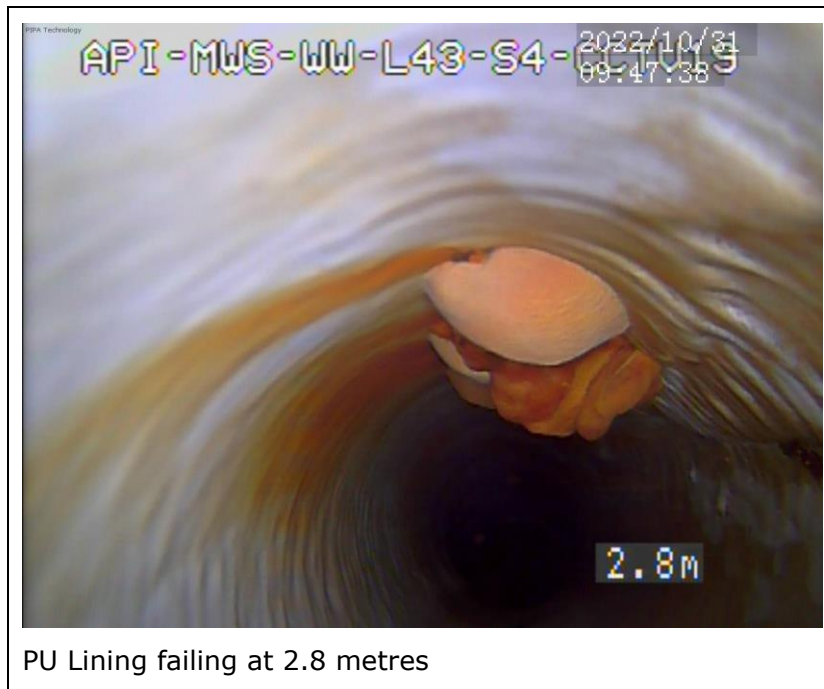
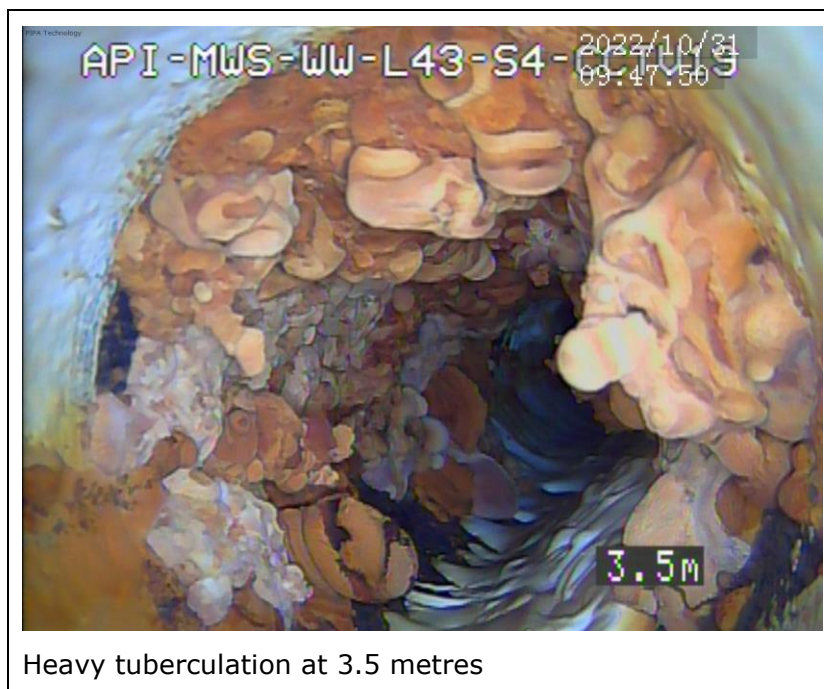
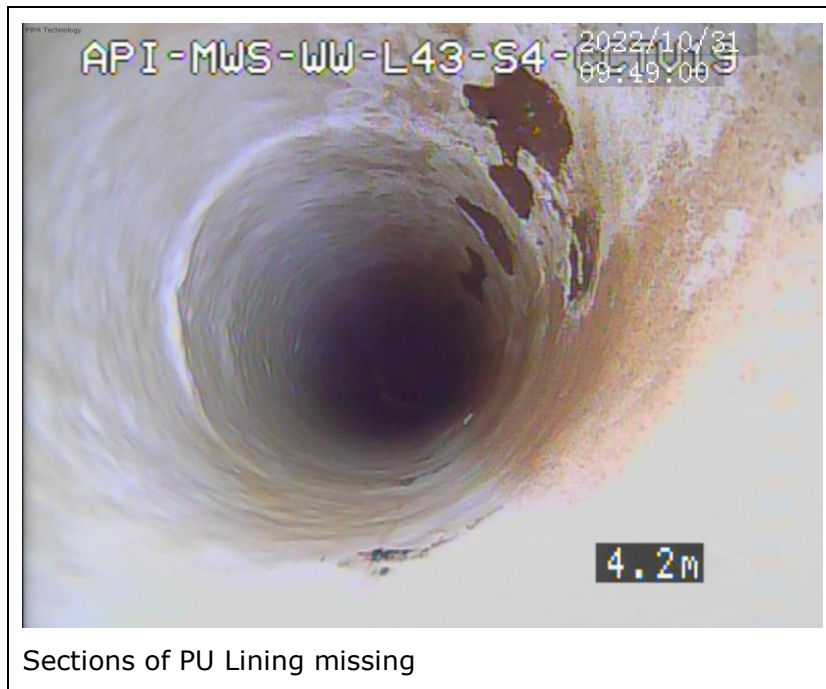
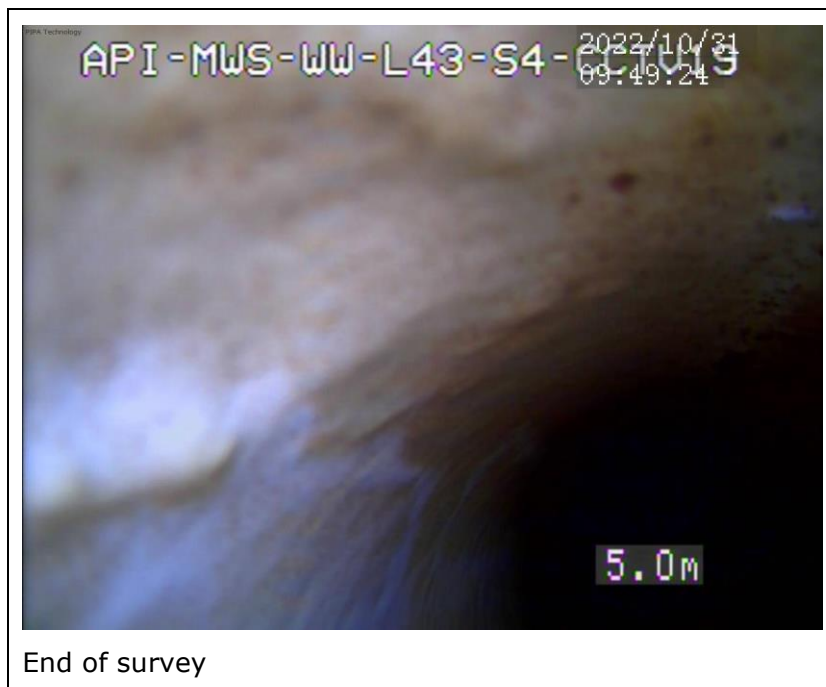
**Direction 1 with flow**

- Medium levels of residual sedimentation identified during survey
- Medium levels of tuberculation identified within the pipeline
- Low levels of debris identified during survey
- Pipeline appears to be in an average condition
- Joints identified at 0.4 metres
- Survey ended at 5 metres due to distance being achieved

- GIS states CI with PU Lining & Profuse PE
- CI with PU Lining confirmed
- Profuse PE not present
- Pipeline is recommended for cleaning scheme

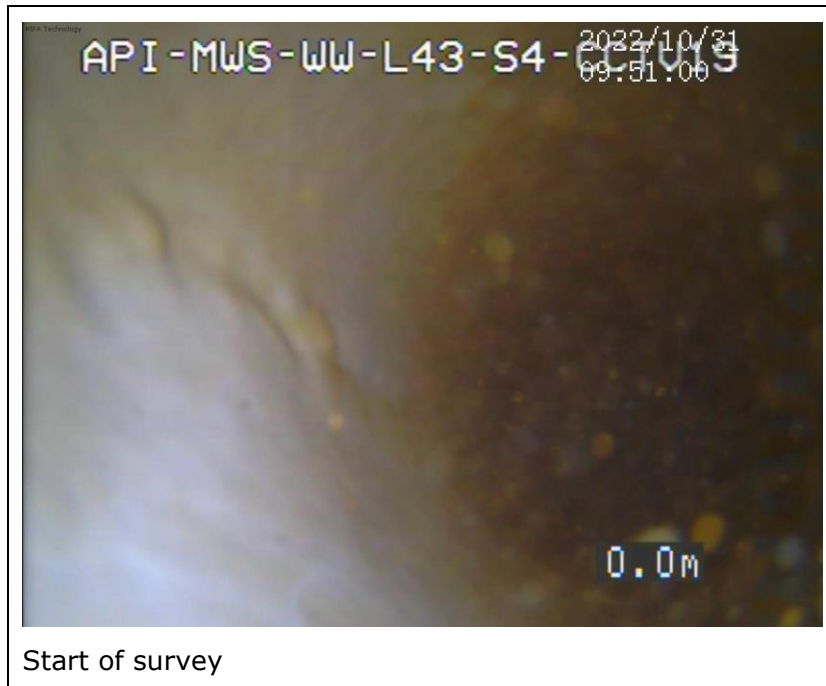
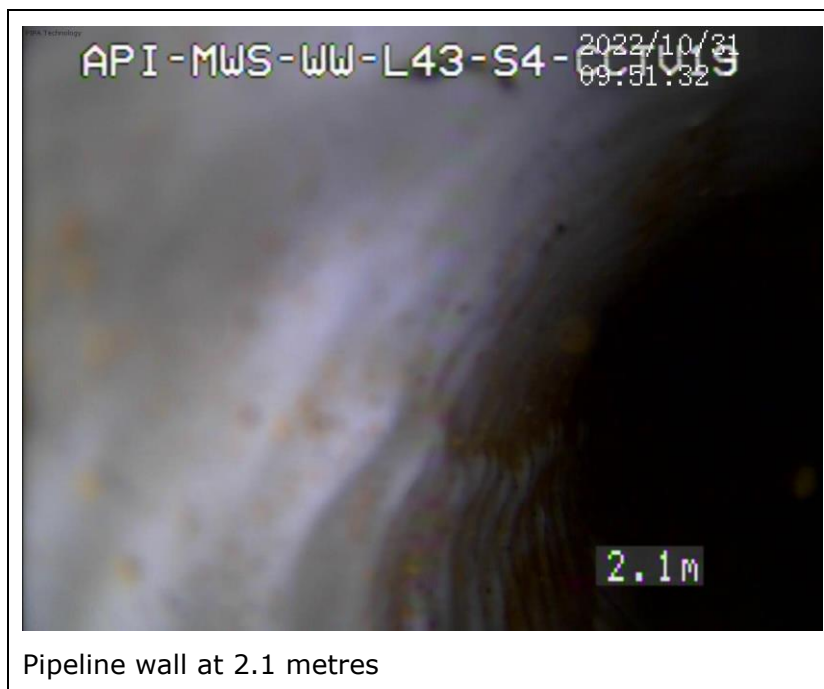
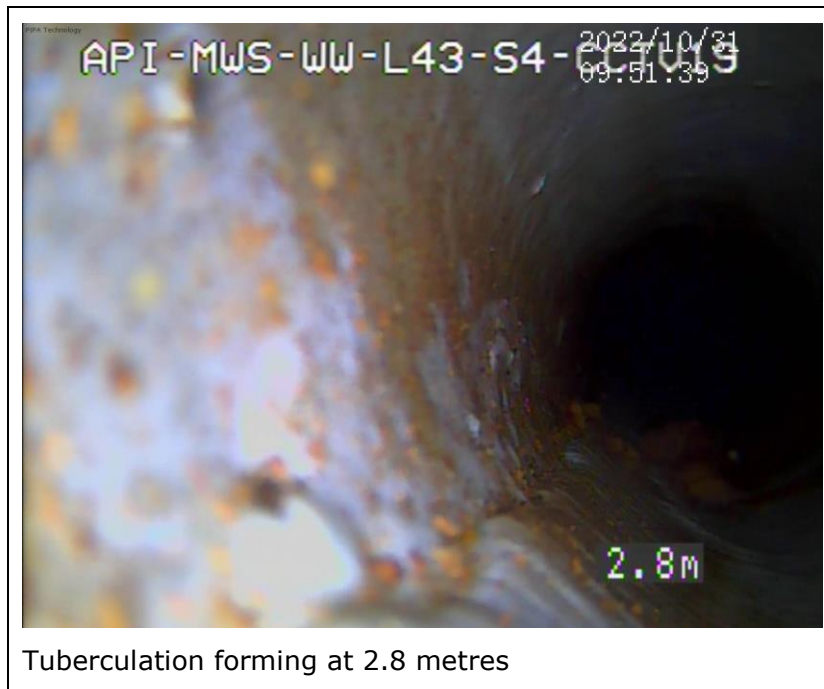
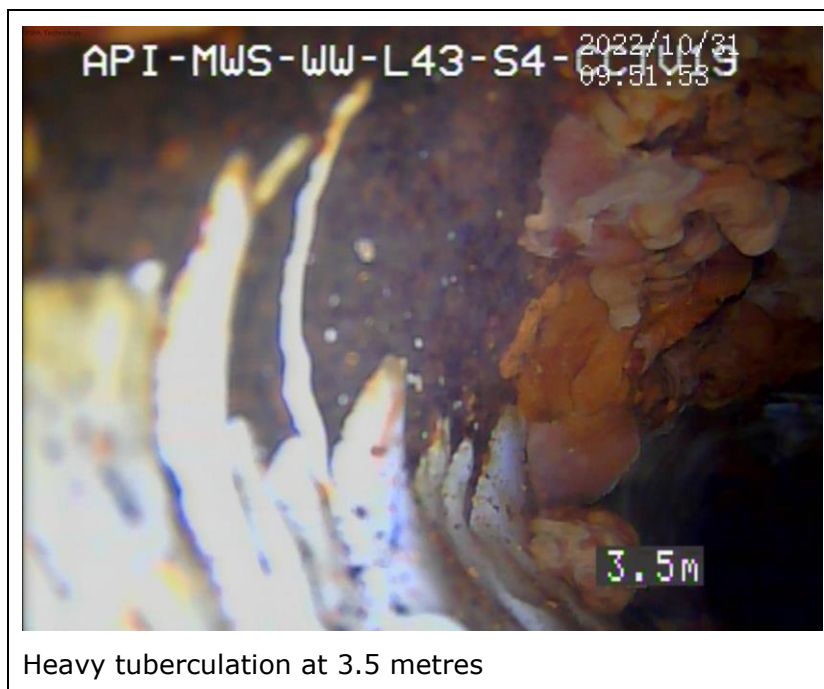
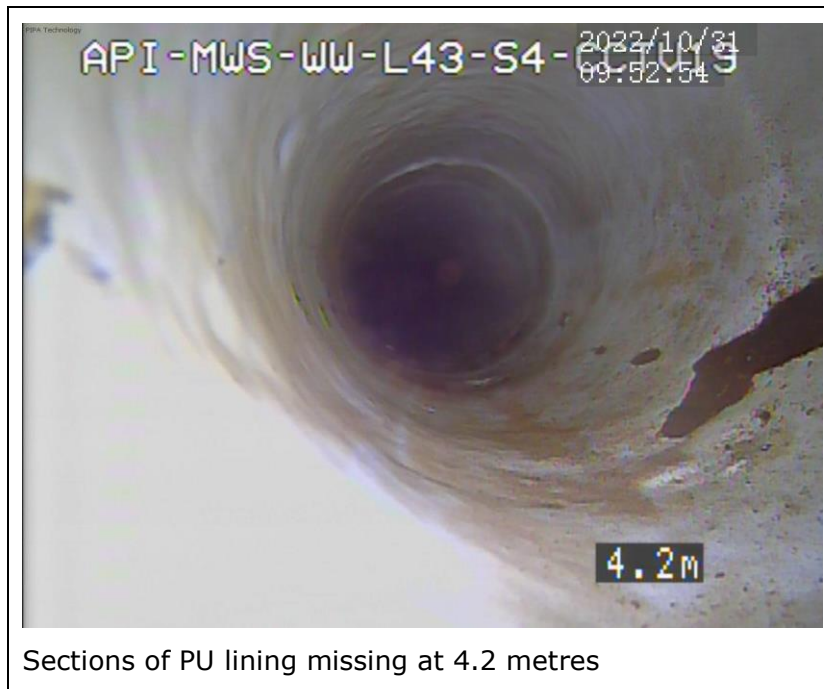
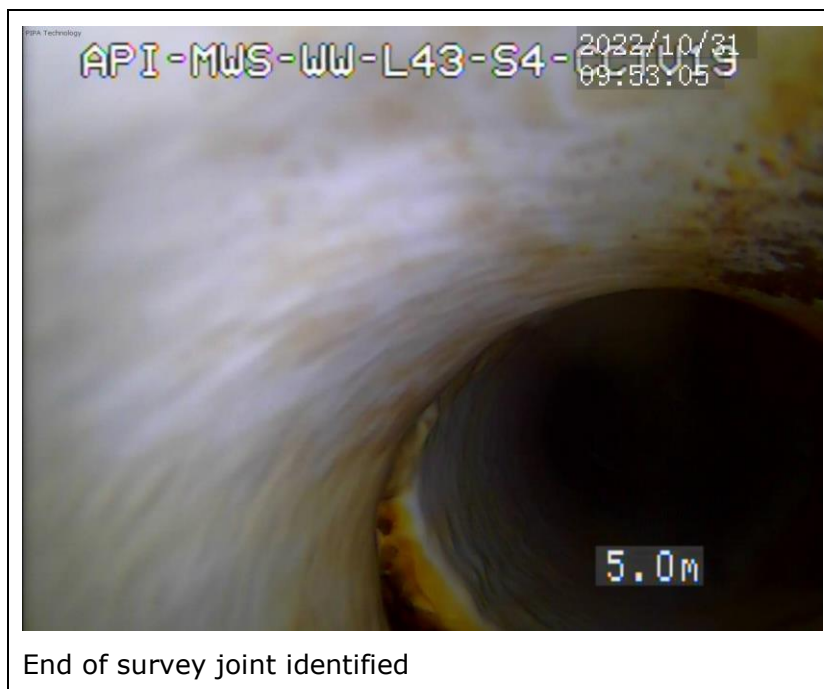
**Direction 2 against flow**

- Medium levels of residual sedimentation identified during survey
- Low levels of tuberculation identified within the pipeline
- Low levels of debris identified during survey
- Pipeline appears to be in an average condition
- Survey ended at 5 metres due to distance being achieved

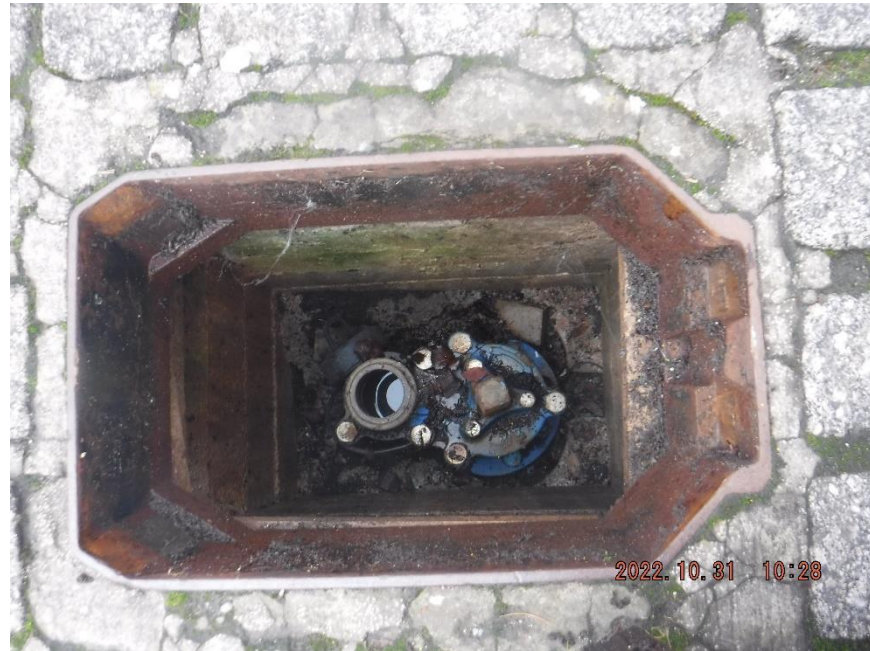
Image of hydrant bowl condition

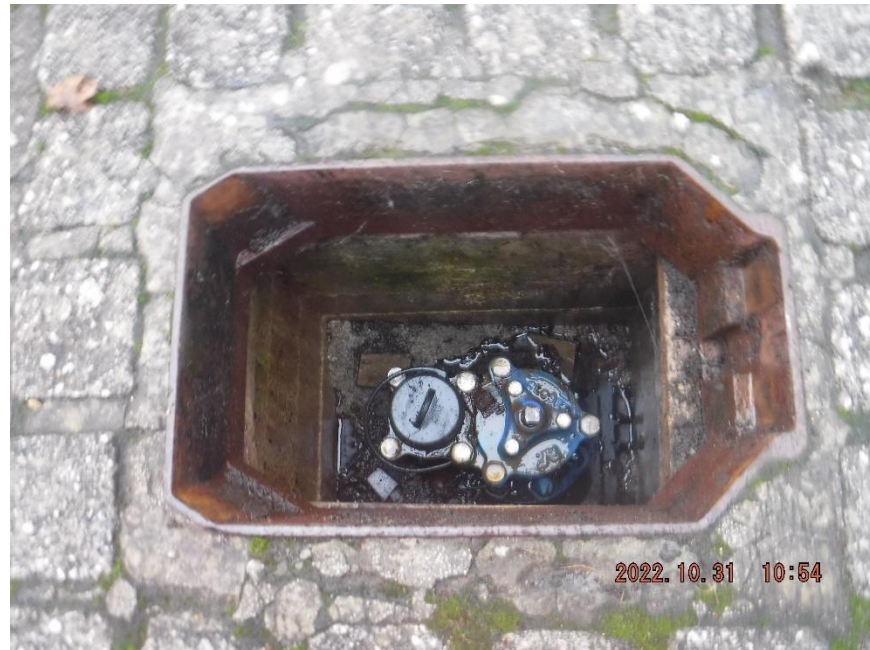
Image of hydrant cap in situ
