## **Pipe Assessment Report**

Pipepod Hydrostatic leakage report produced on behalf of:  
SAMPLE

### **Acoustic Inspection Project Scope**

A pressurised acoustic survey was undertaken on a potable water pipeline to locate a possible leak or leaks within a pipeline section.

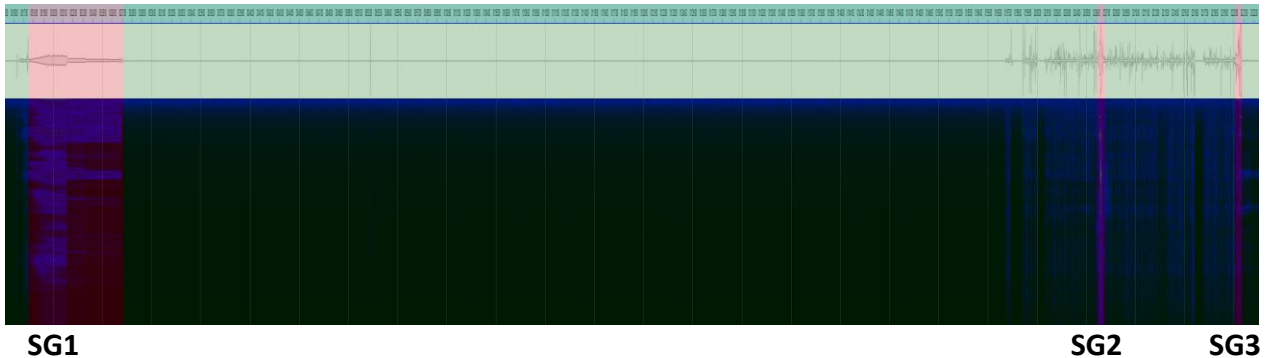
### Additional Information – Acoustic Scanning Details (leak analysis)

3 clear acoustic band signatures are observed during the post analysis of the recorded inspection footage; graph indicates pressurisation and depressurisation of the sensor. Also an acoustic peak is identified at 67-68 metres.

- SG1 illustrates the pipeline being pressurised at the start of the survey
- **SG2 illustrates an acoustic point of interest or leak identified at 67-68 metres from Pipepod entry point (excavation in park area)**
- SG3 illustrates water injection and water passing of the exit chamber

No other acoustic peaks identified (leaks) during the data post analysis of the acoustic data. PIPA Software identifies leaks and illustrates points of interest with solid red banding (see spectrograph above).

Sporadic sound spikes are also present (sensor drag or contacting pipe wall only).

Possible leak detected during survey undertaken at 8-9.44 bar pressure only.

It is recommended that the pipeline section is repaired and retested to see if pipe section passes a hydrostatic test.
