## **Pipe Assessment Report**

CCTV/Acoustic Commissioncam™ leakage and inspection report  
produced on behalf of:  
SAMPLE

A pressurised CCTV and acoustic survey was undertaken on a new installation potable water pipeline to locate a possible leak or leaks within a pipeline section. The survey was completed to also confirm that the pipe was clean and free of debris as part of the commissioning procedure.

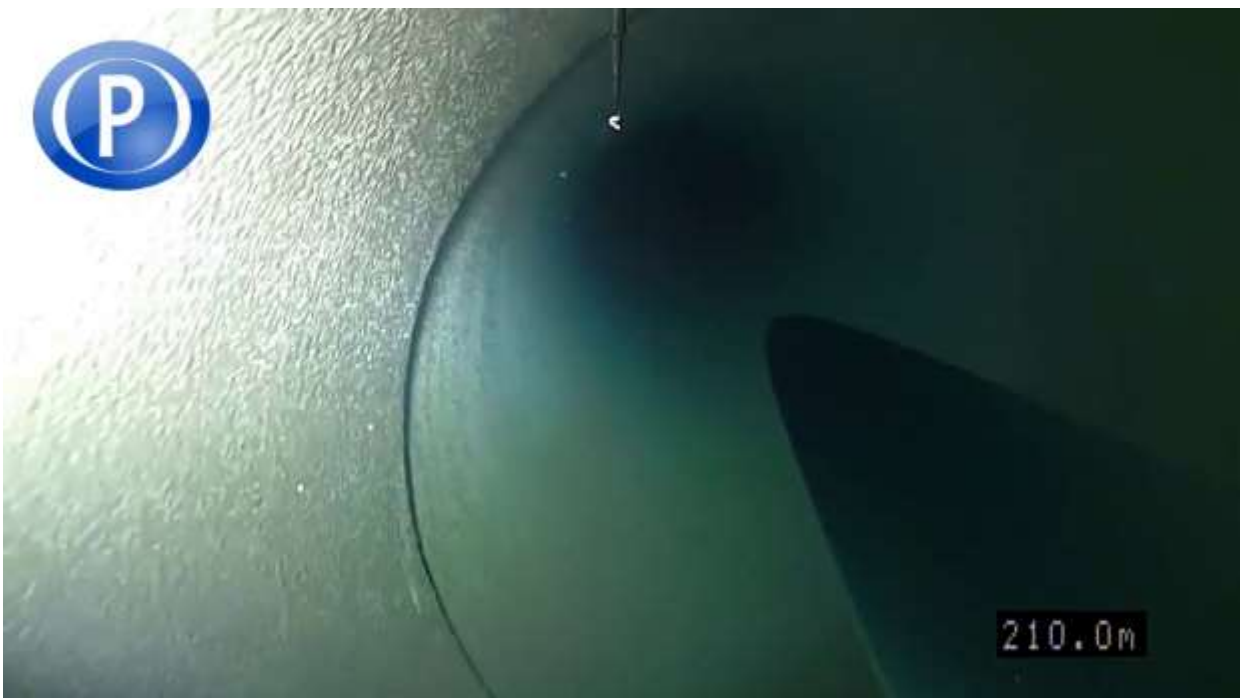
**Air pocket identified**

Areas of entrapped air pockets are also observed during the pipe inspection survey.

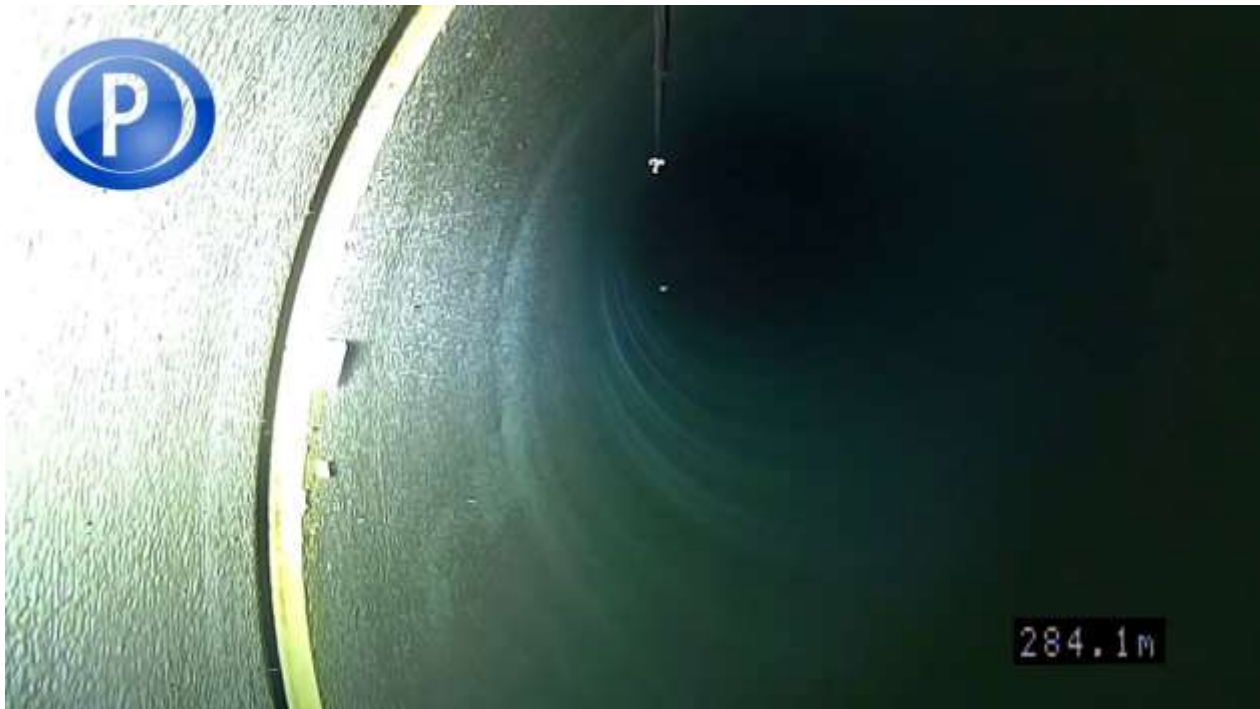
Wide joint image

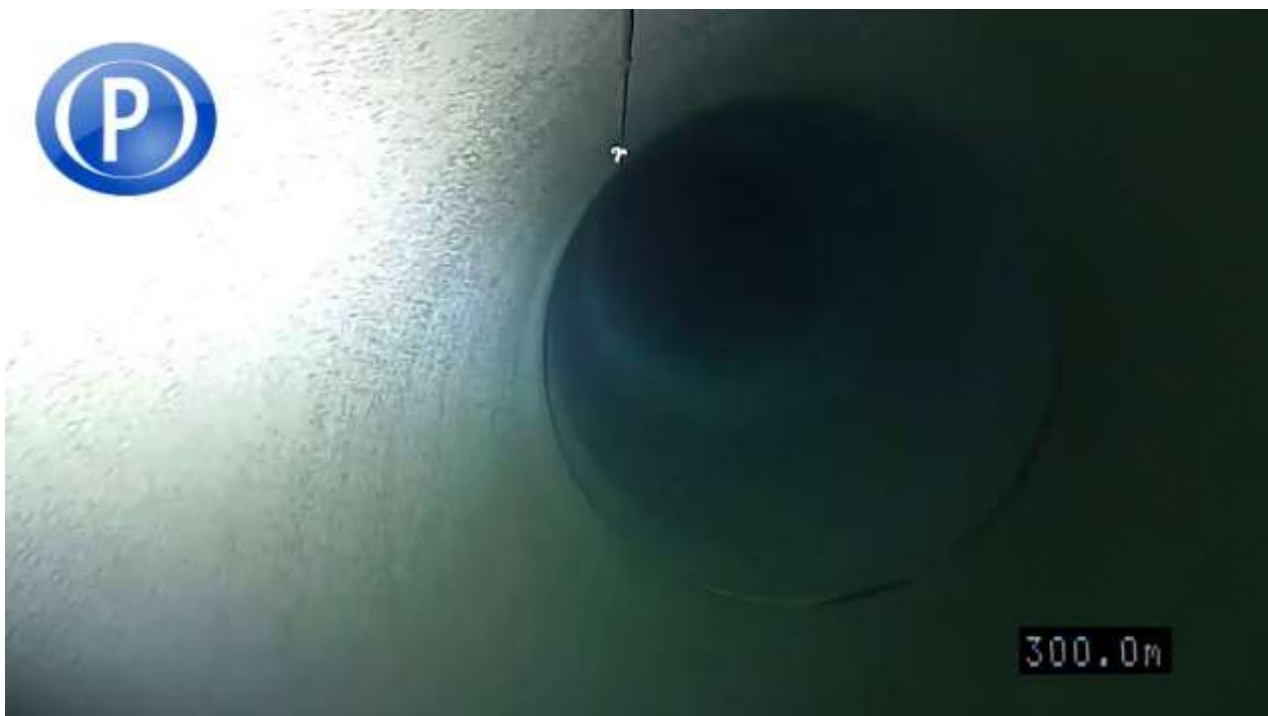
Joint image possible gasket and wide joint (this point recorded an acoustic POI)

Both by using software analysis and by listening to the recorded file, there is a short acoustic point of interest identified at 4 hours, 18 minutes and 18 seconds, this equates to the area of 300 metres from sensor insertion point. Site investigations should focus on pipe joints within this area.

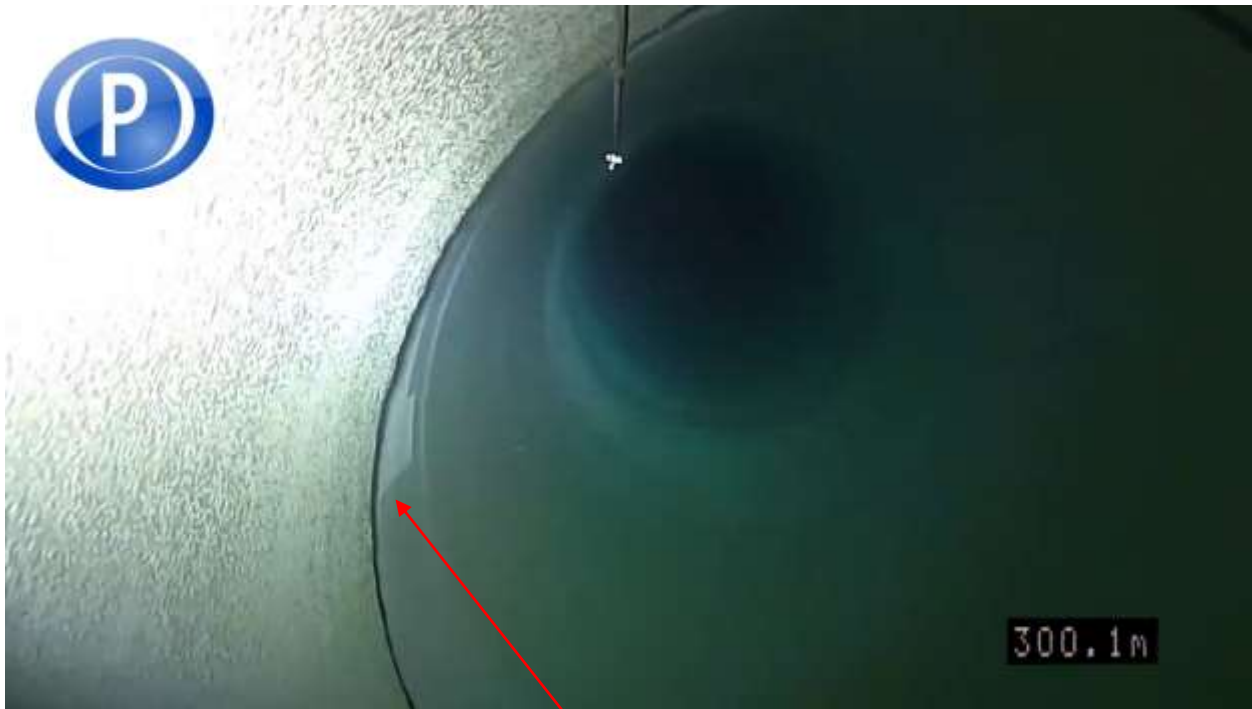
Some acoustic interest identified and non-uniform joint

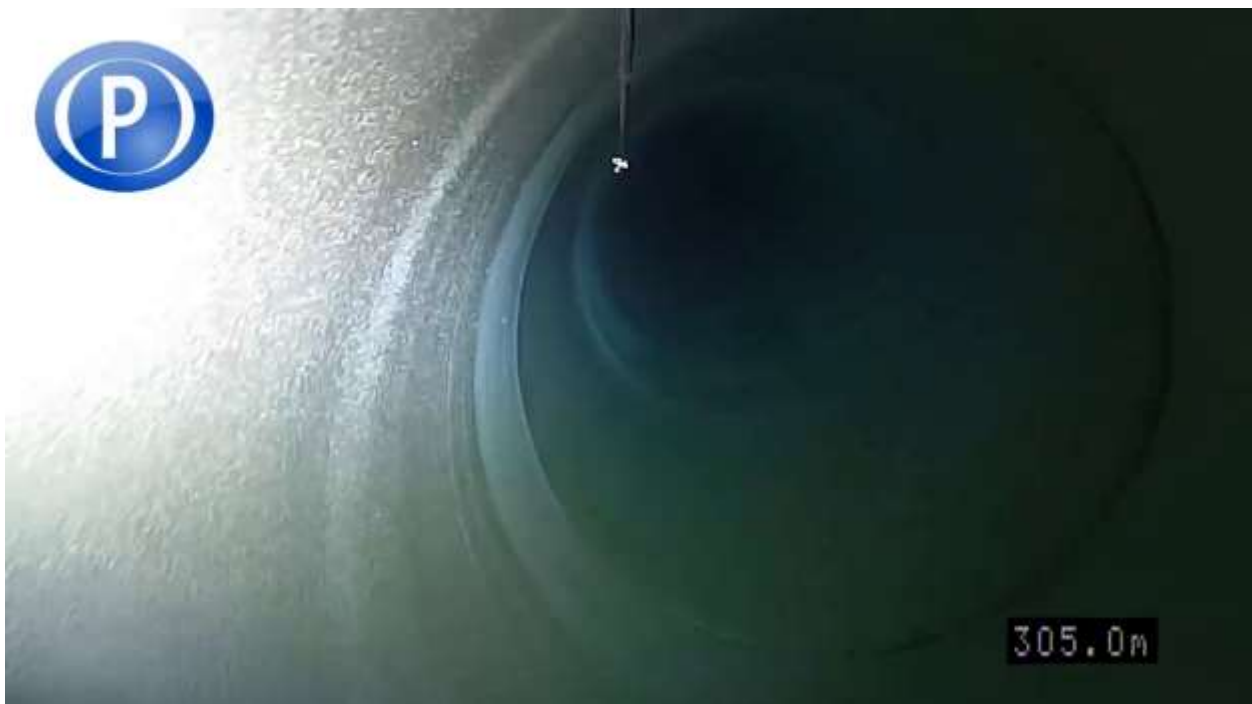
Wide Joint image

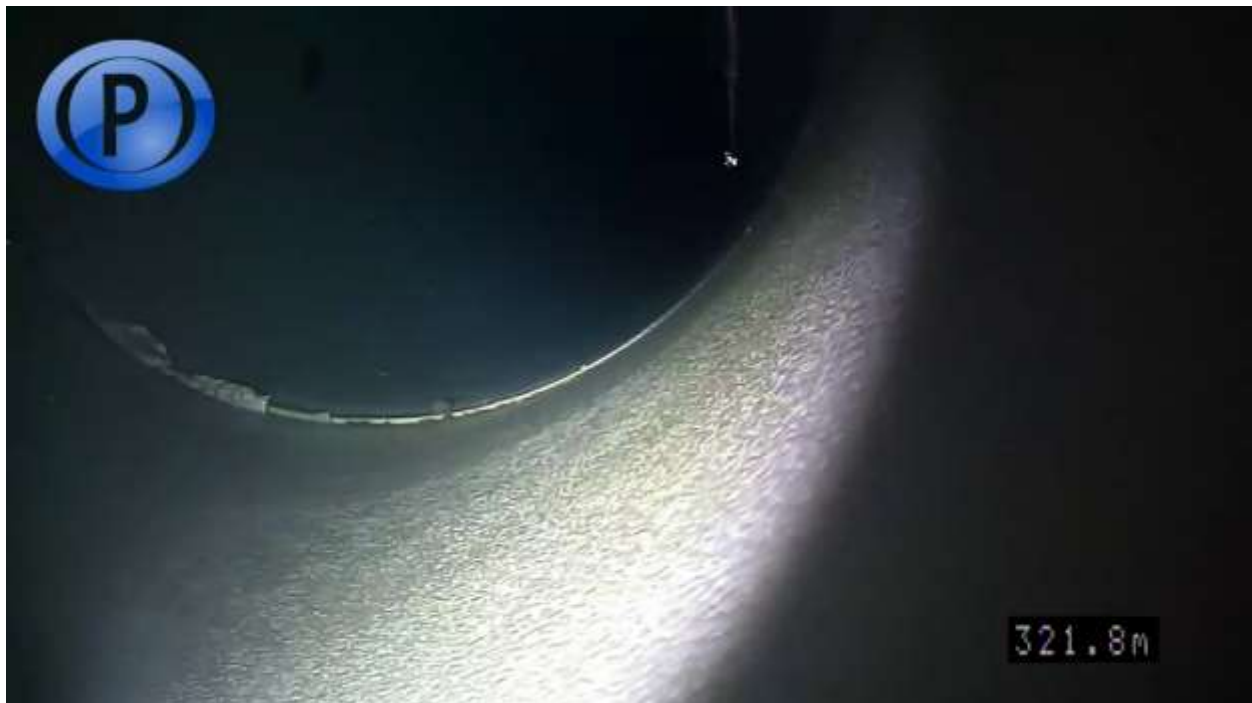
Debris on joint image

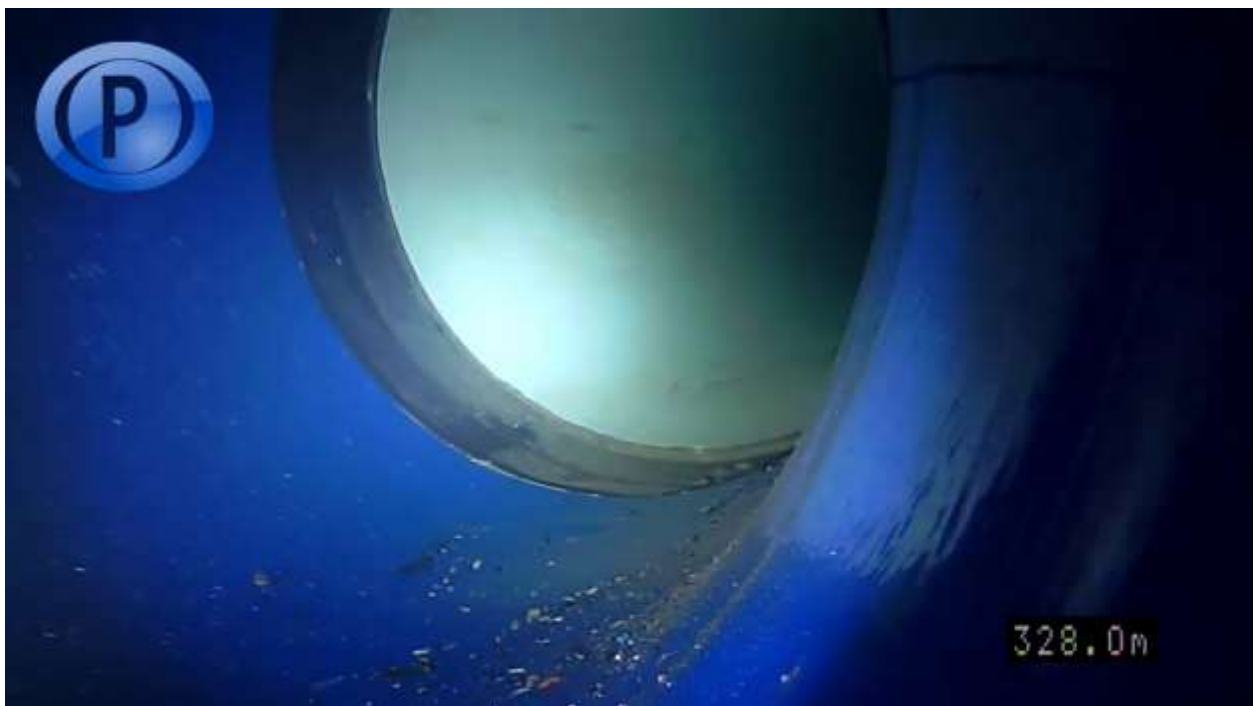
Bend image with debris identified

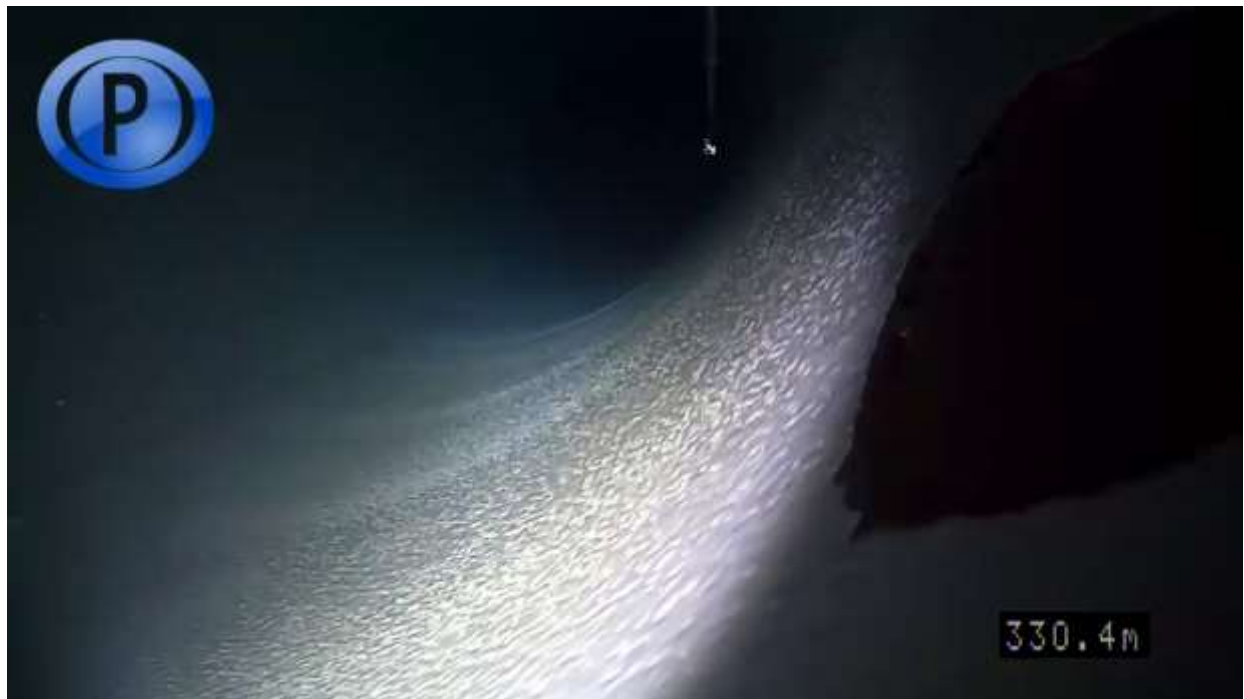
Possible failure of cement lining

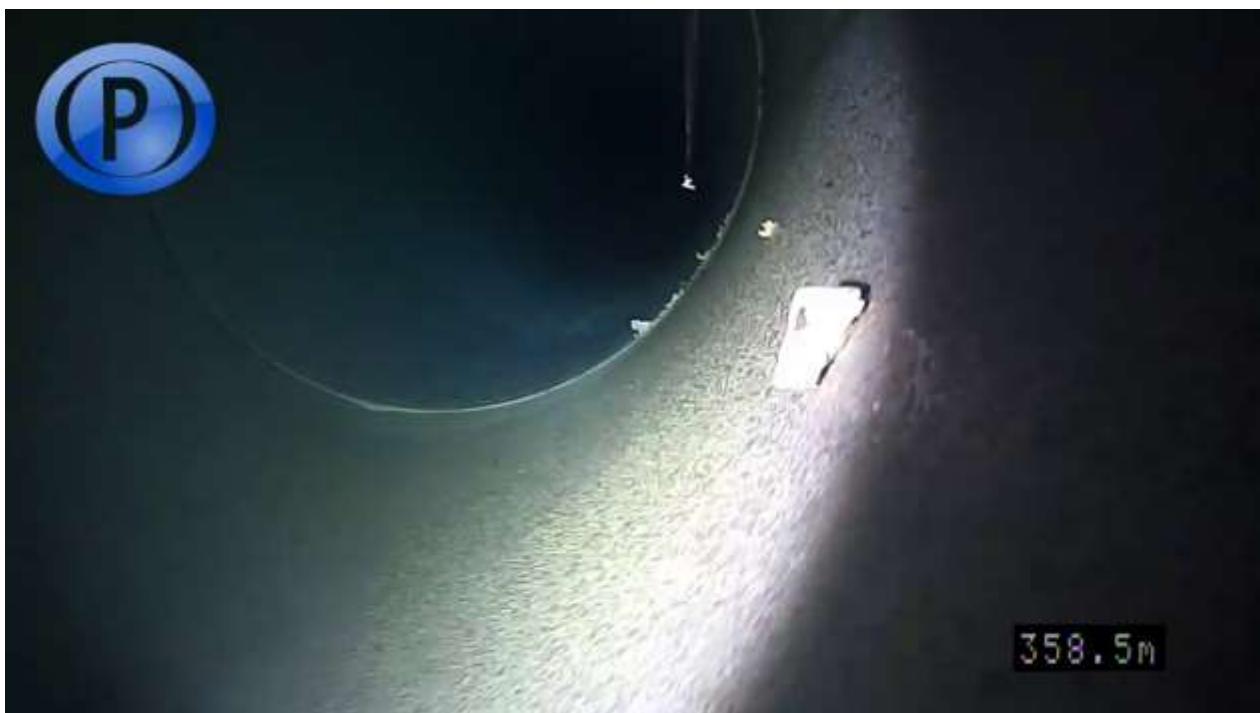
Joint image with debris identified

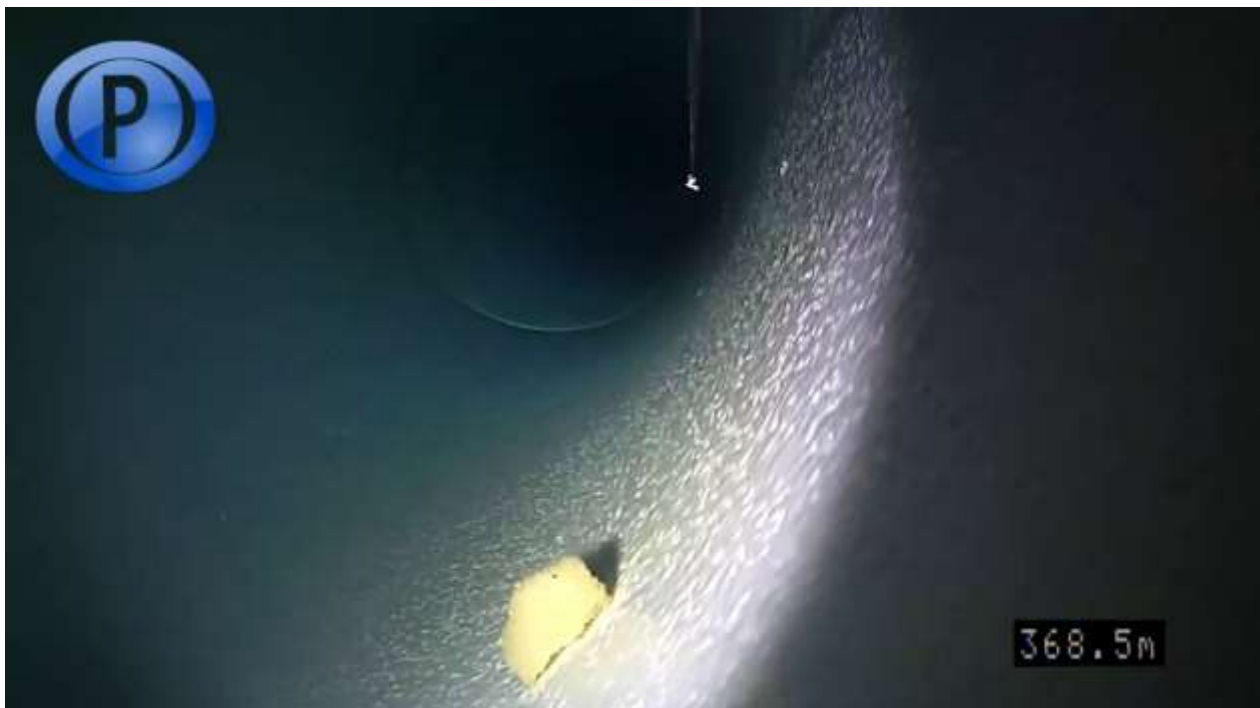
Joint image with debris identified

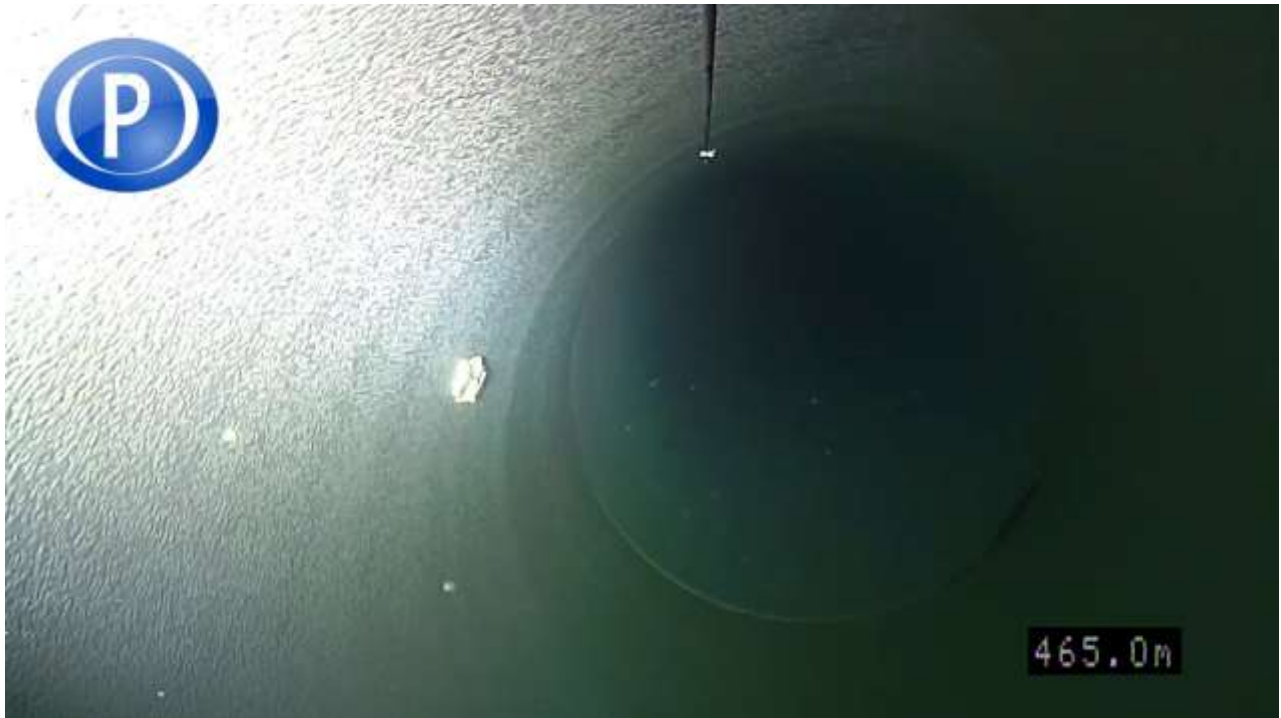
Joint image with possible gasket identified

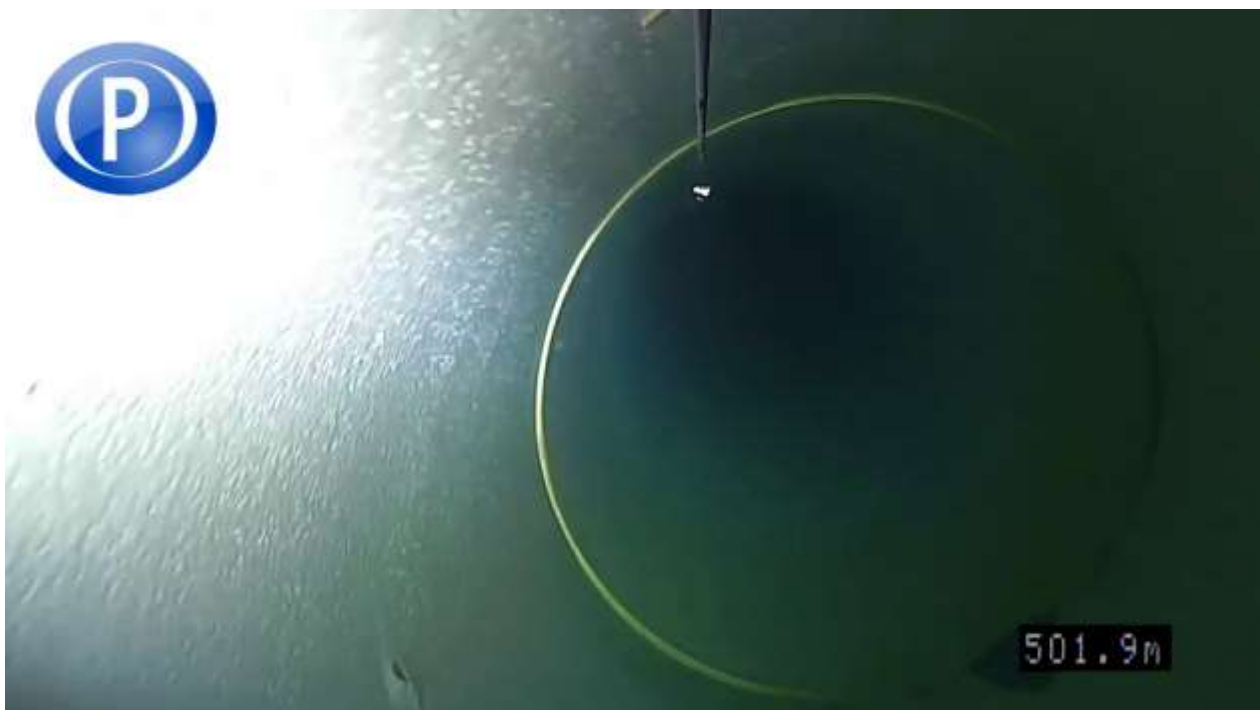
Joint image with failure of lining identified

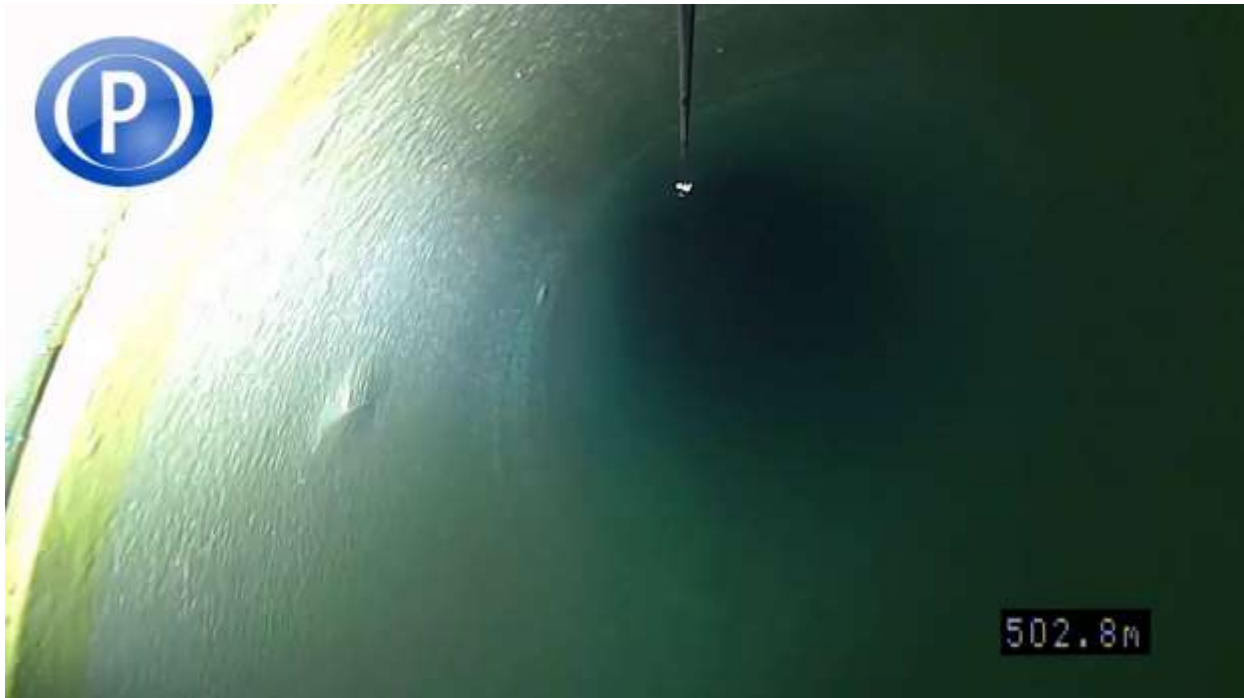
Main image with blistering of lining identified

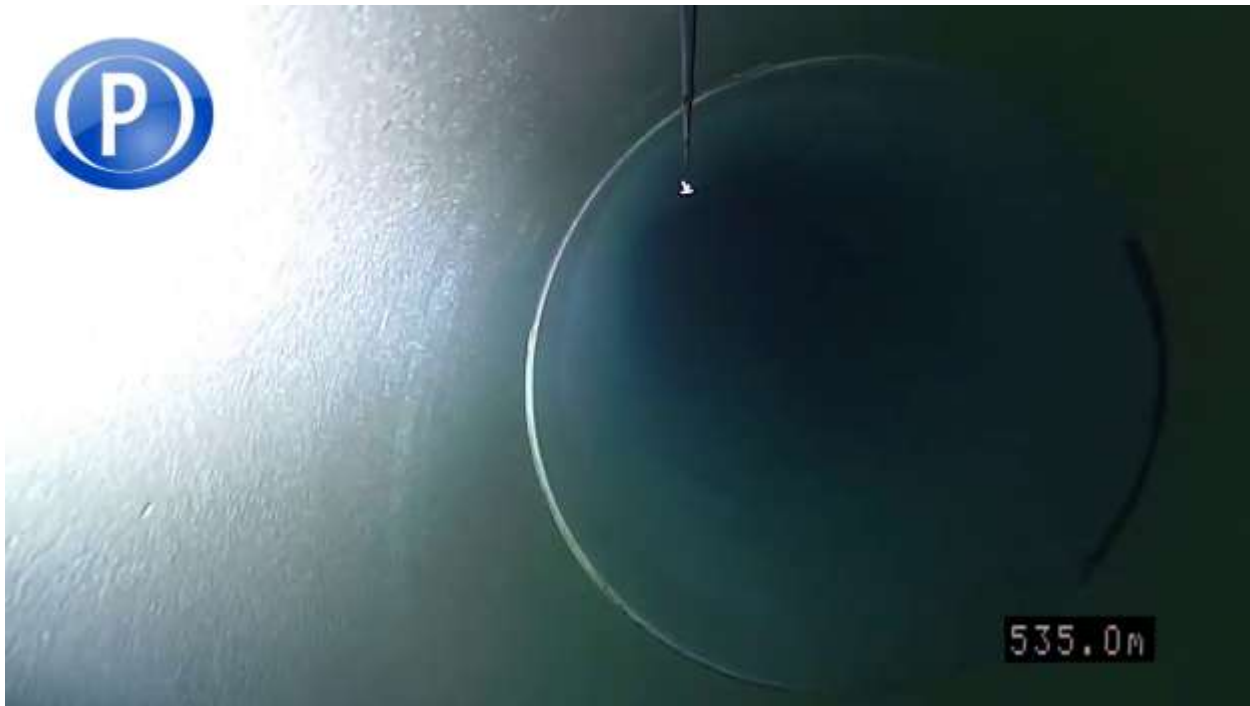
Joint image with possible gasket identified

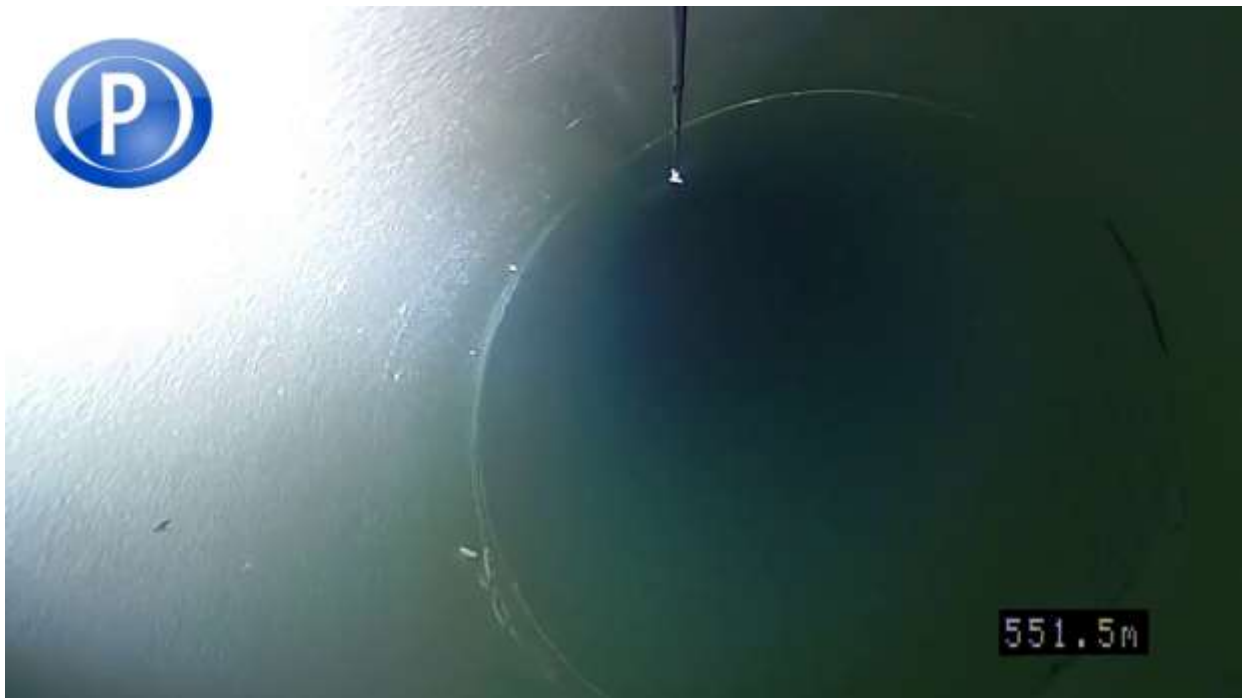
Joint image with possible gasket identified

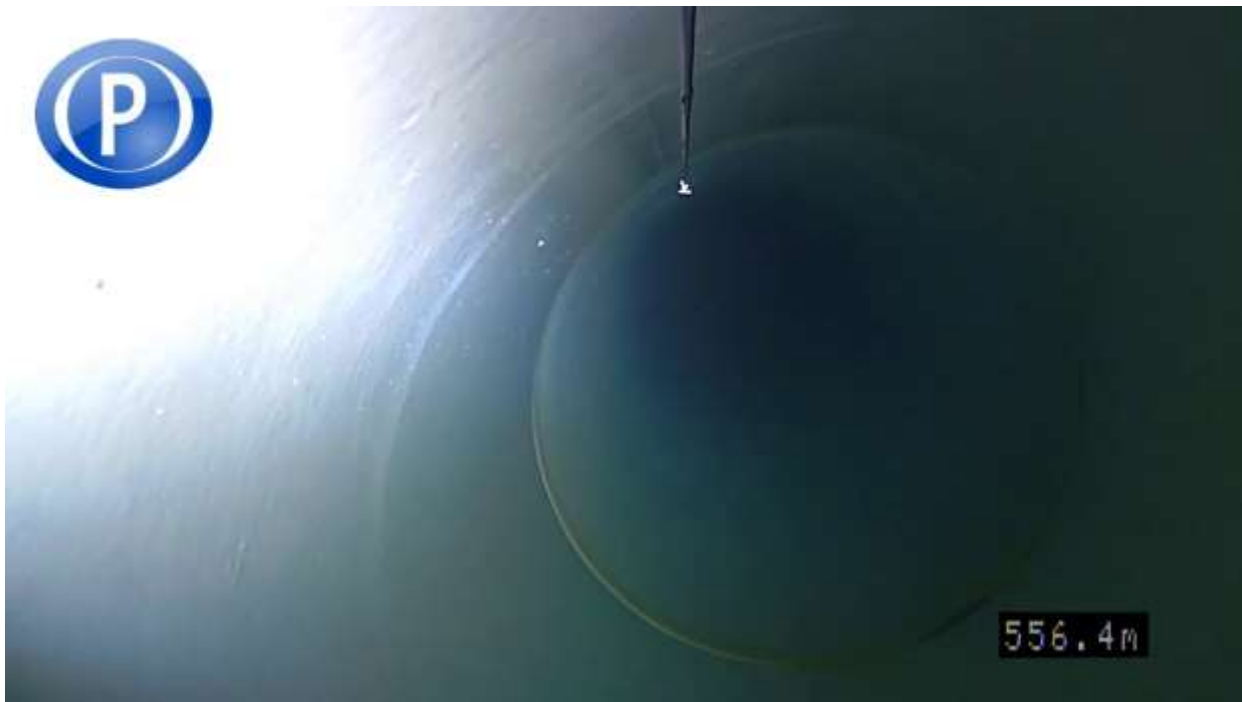
Joint image with possible gasket identified

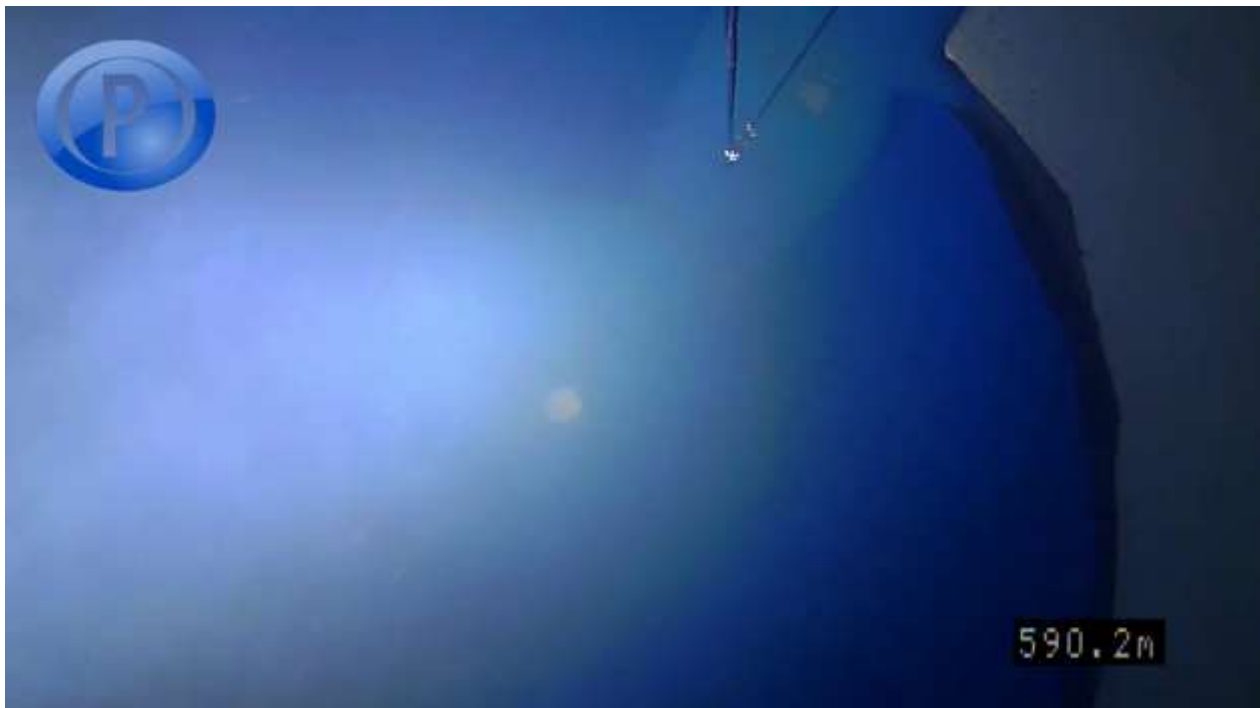
**Wide joint at exit point identified**

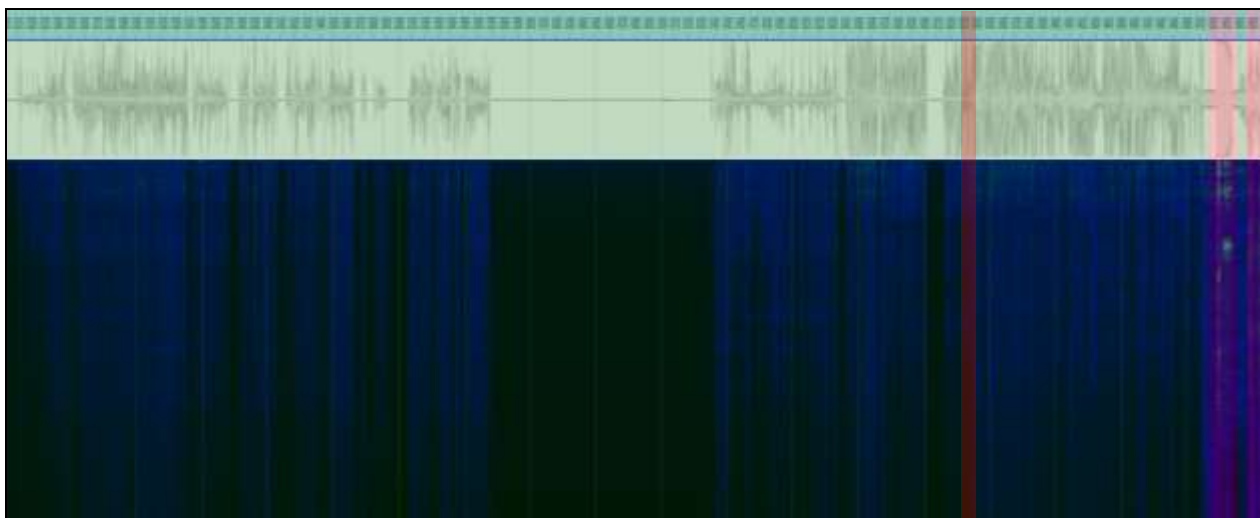
SG1  
Full spectrograph

One clear acoustic band signature is observed during the post analysis of the recorded inspection footage; graph also indicates pressurisation and depressurisation of the sensor.

- SG1 illustrates the sensor moving at the start of the survey
- SG2 illustrates the sensor moving during the survey
- SG3 illustrates water injection and water passing of the exit chamber

No other acoustic peaks identified (leaks) during the data post analysis of the acoustic data. PIPA Software identifies leaks and illustrates points of interest with solid red banding (see spectrograph above).
