## **Water Pipe Assessment Report**

**CCTV/Acoustic inspection report produced on behalf of:  
SAMPLE REPORT**

# Flowrider Pressurised Pipe Internal Inspection Report

| <b>API Staff on site:</b> | SAMPLE | API-Pipewell<br>Road L7-L6 |

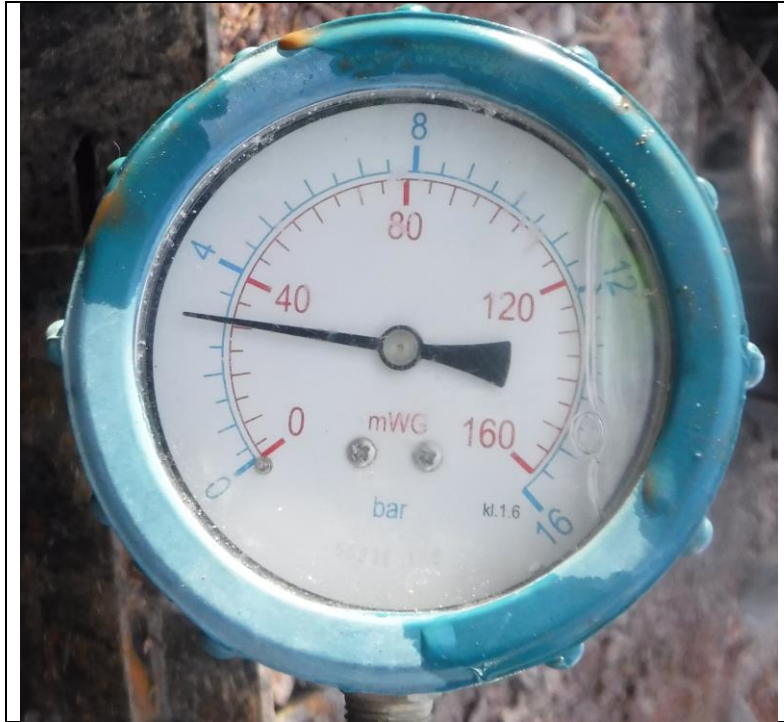
Pressure reading taken on site (actual):

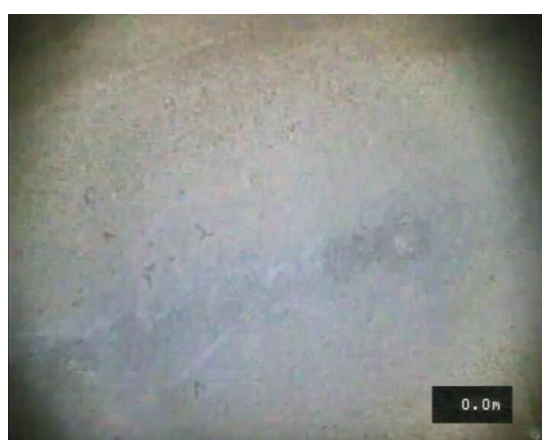
#### Title 1

Image at pipe insertion point

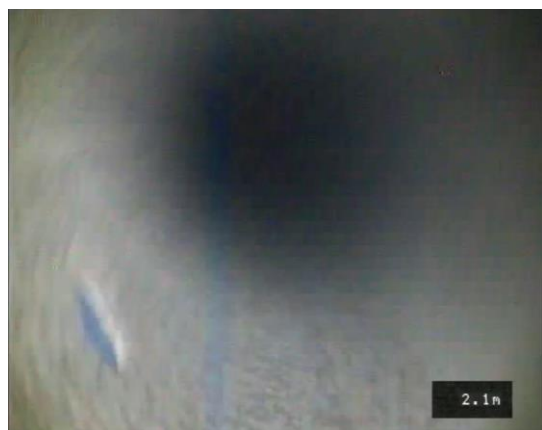
#### Title 2

Hydrant branch cut out identified

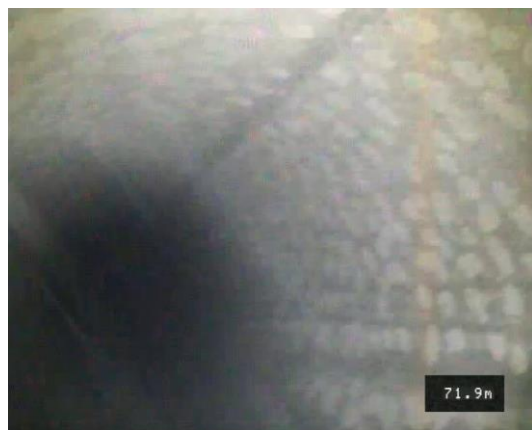
### Title 17

Pitting of cement lining identified

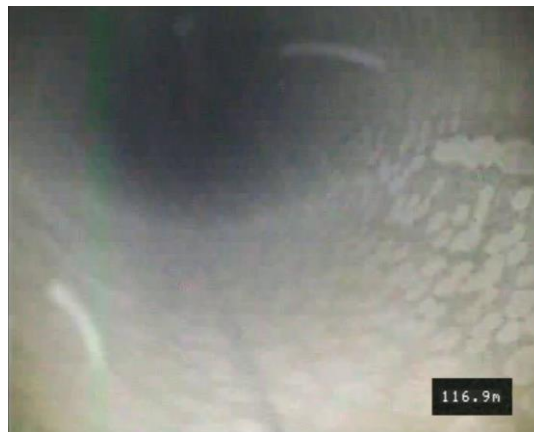
**Title 26**

Pitting of cement lining identified

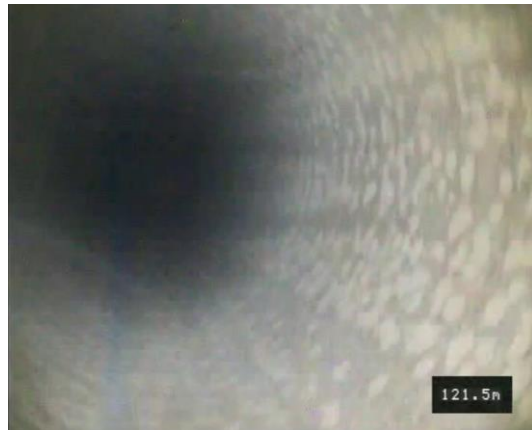
**Title 28**

Pitting of cement lining identified

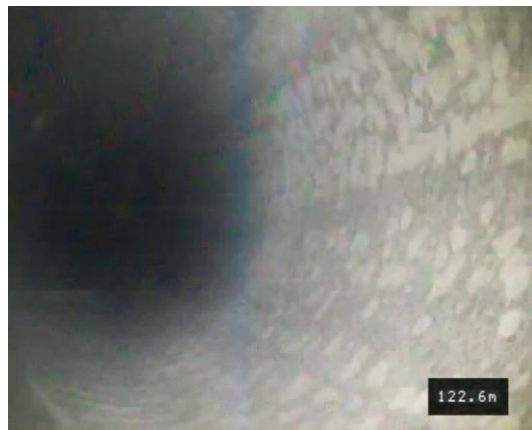
**Title 29**

Pitting of cement lining identified

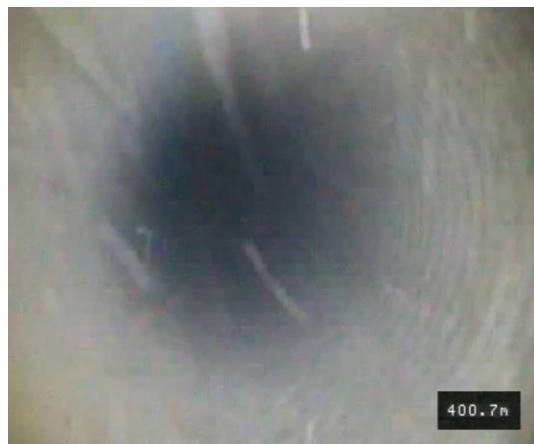
### Title 98

Image of main and end of survey

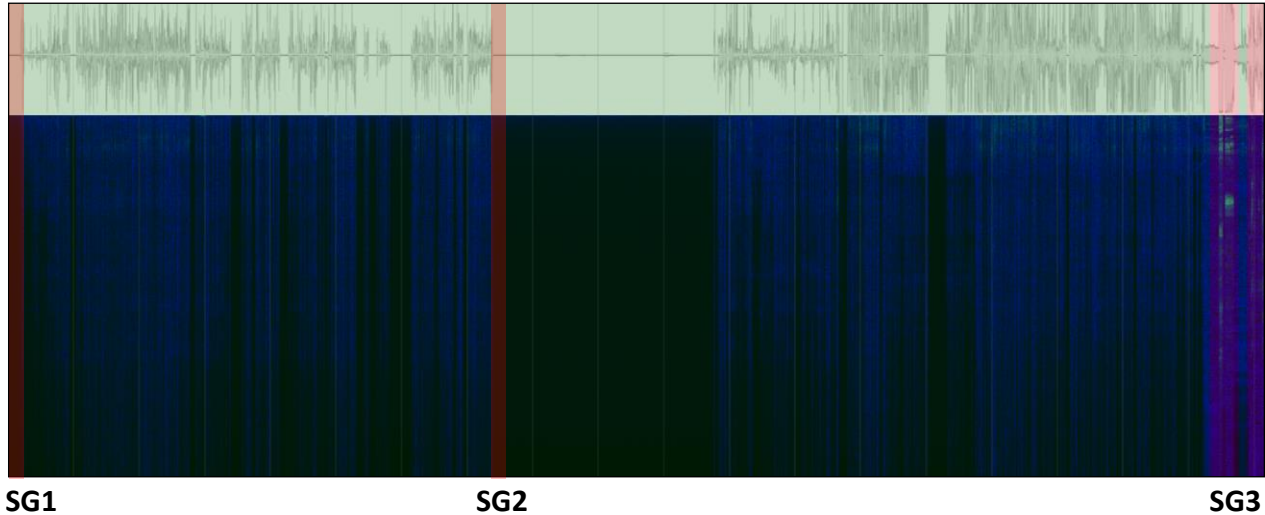
3 clear acoustic band signatures are observed during the post analysis of the recorded inspection footage acoustics:

- SG1 illustrates the sensor being pressurised at the start of the survey
- SG2 illustrates the sensor hydrochute being collapsed remotely during the survey
- SG3 illustrates water injection sound and depressurisation of the launch tube

No other acoustic peaks identified (leaks) during the data post analysis of the acoustic data. PIPA Software identifies leaks and illustrates points of interest with solid red banding (see spectrograph above).

Sporadic sound spikes are also present (sensor drag or contacting pipe wall only).

Possible leak detected during survey undertaken at 3 bar pressure only.

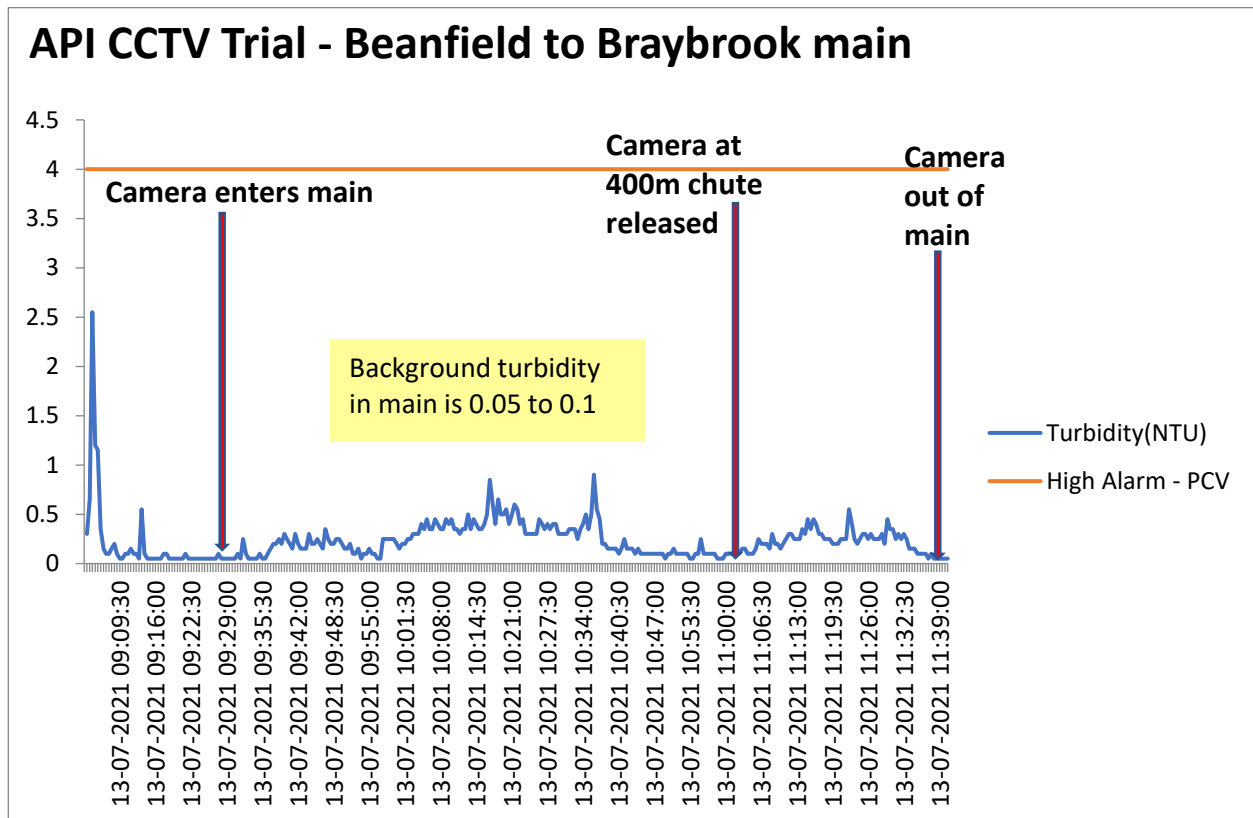
The graph above shows that the turbidity level recorded whilst deploying the Flowrider system remained below level 1. This result has confirmed that using the system is safe and approved for use in potable water mains.
