## **Pipe Assessment Report**

CCTV/Acoustic Commissioncam™ leakage and inspection report  
produced on behalf of:  
SAMPLE

A pressurised CCTV and acoustic survey was undertaken on a new installation potable water pipeline to locate a possible leak or leaks within a pipeline section. The survey was completed to also confirm that the pipe was clean and free of debris as part of the commissioning procedure.

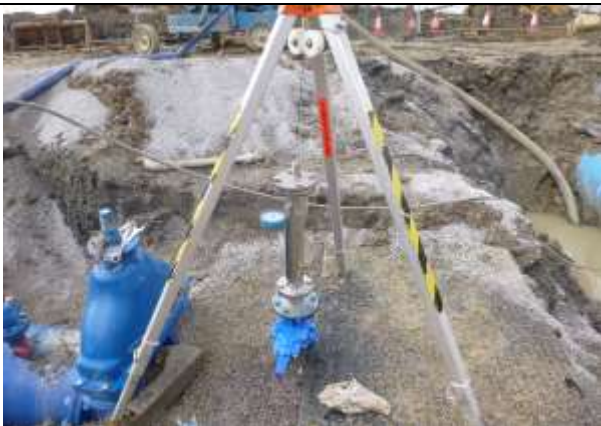
Site Location B: System entry point
