## **Water Pipe Assessment Report**

**CCTV/Acoustic inspection report produced on behalf of:  
SAMPLE REPORT**

# Flowrider Pressurised Pipe Internal Inspection Report

| <b>API Staff on site:</b> | SAMPLE | API-Pipewell<br>Road L7-L6 |

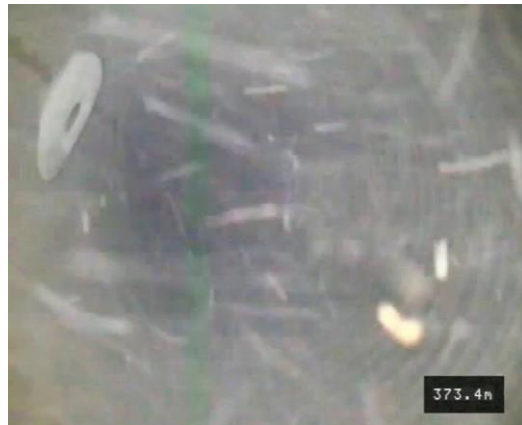
### Title 88

Drilled cement lining coupon identified

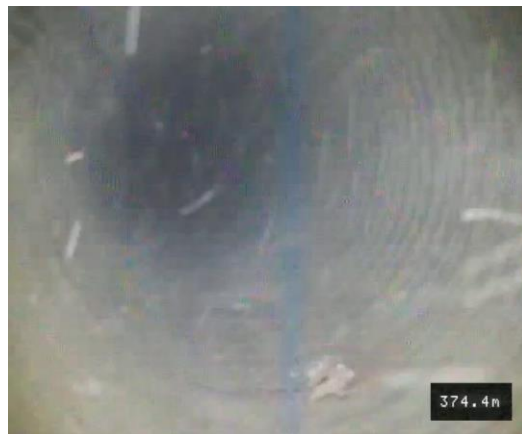
### Title 89

Debris in pipe identified
