## **Pipe Assessment Report**

CCTV/Acoustic Commissioncam™ leakage and inspection report  
produced on behalf of:  
SAMPLE

A pressurised CCTV and acoustic survey was undertaken on a new installation potable water pipeline to locate a possible leak or leaks within a pipeline section. The survey was completed to also confirm that the pipe was clean and free of debris as part of the commissioning procedure.

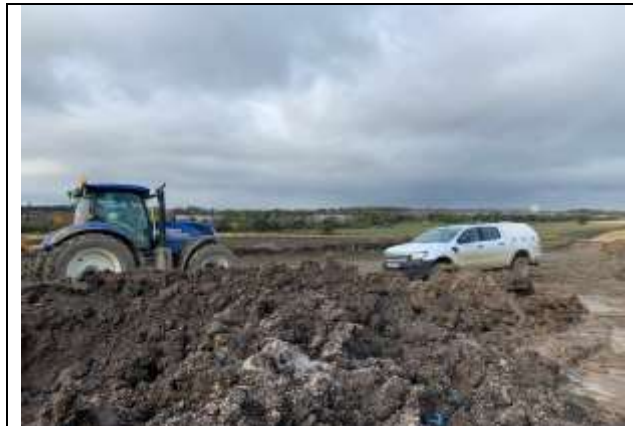
System exit point top of hill:

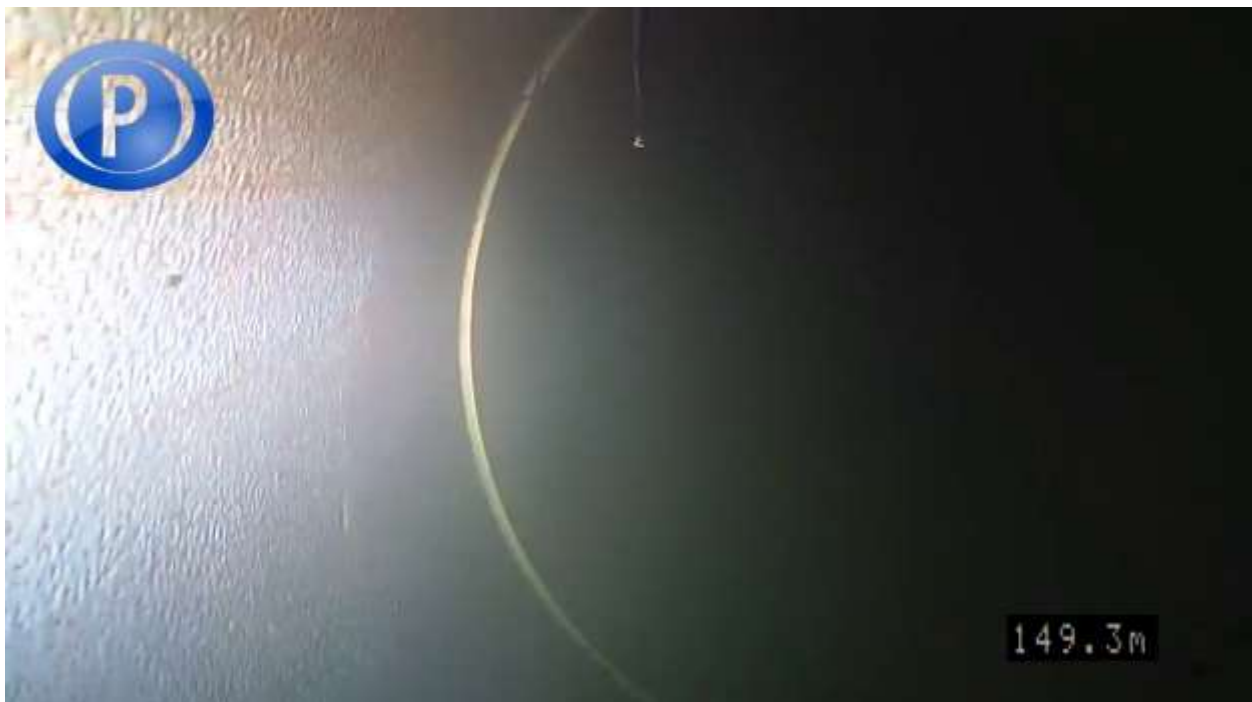
Good water clarity

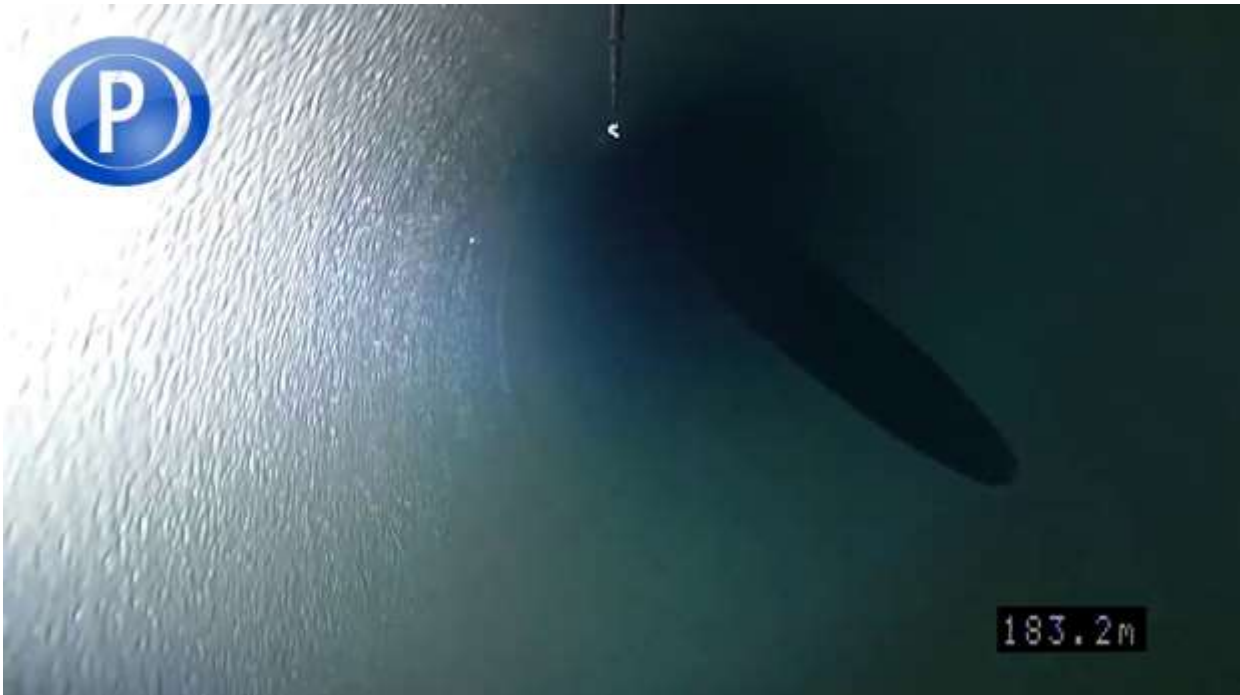
**Air pocket identified**

Areas of entrapped air pockets are also observed during the pipe inspection survey.

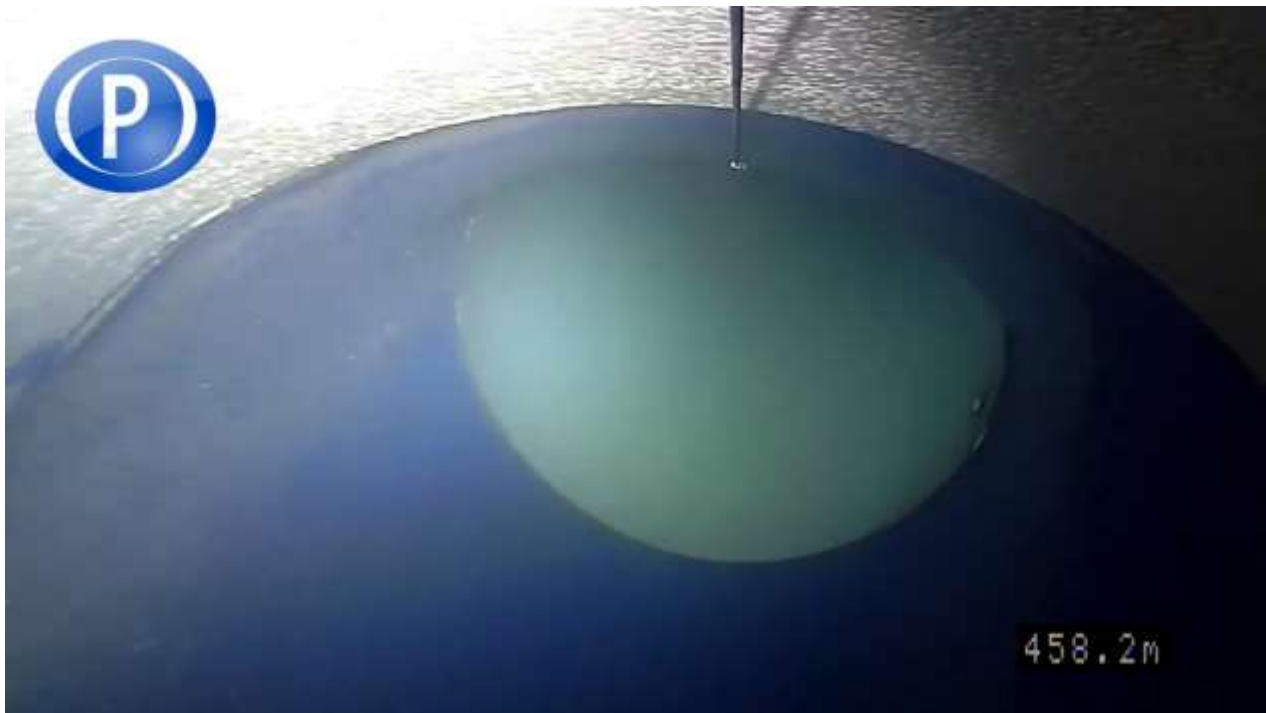
Bend image

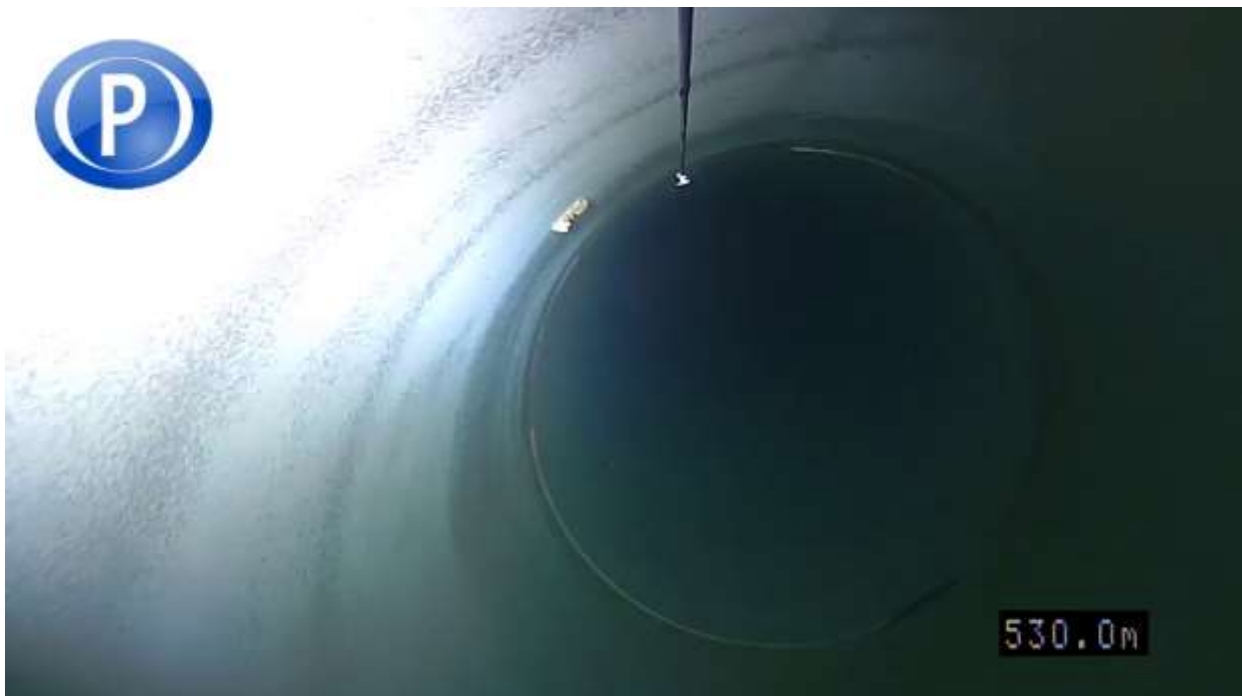
Joint image possible gasket identified

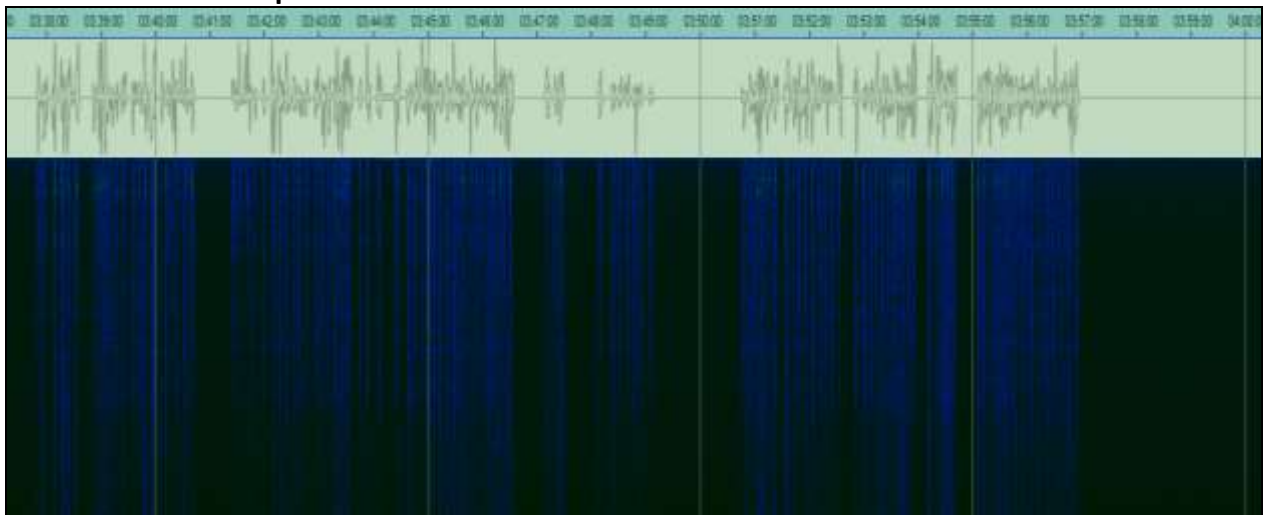
**100-225m No acoustic point of interest identified**
