## **Water Pipe Assessment Report**

**CCTV/Acoustic inspection report produced on behalf of:  
SAMPLE REPORT**

# Flowrider Pressurised Pipe Internal Inspection Report

| <b>API Staff on site:</b> | SAMPLE | API-Pipewell<br>Road L7-L6 |

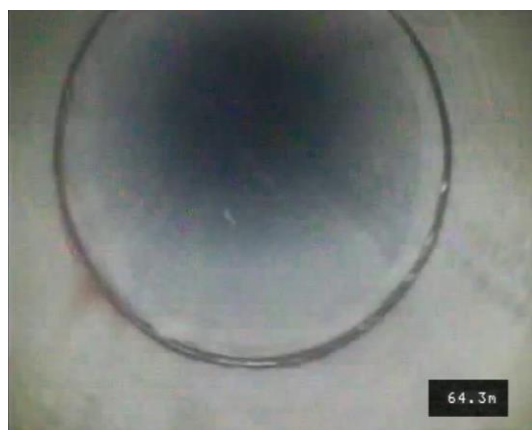
**Title 15**

Joint image

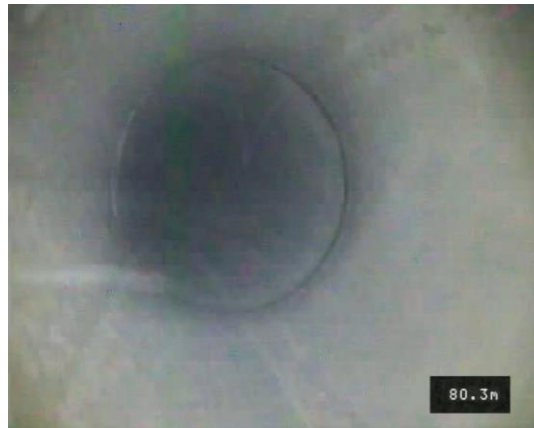
**Title 19**

Joint image

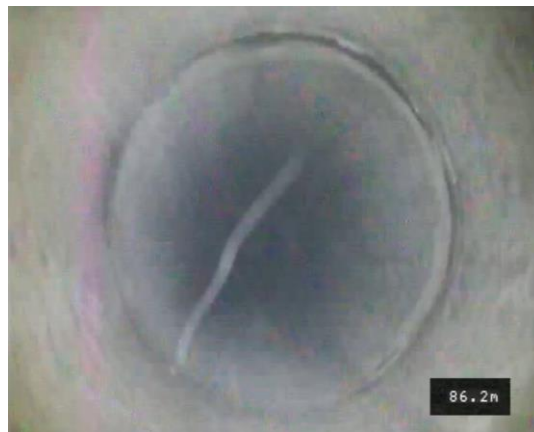
**Title 20**

Joint image

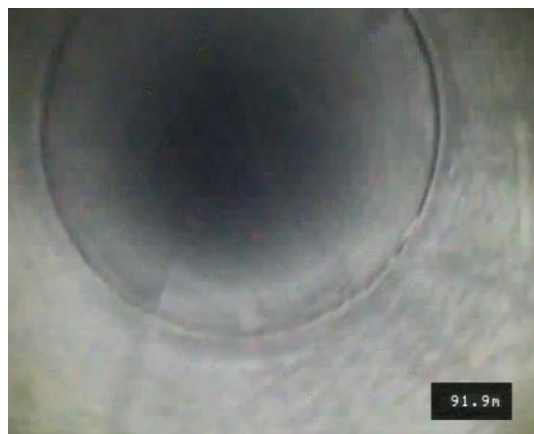
**Title 21**

Joint image

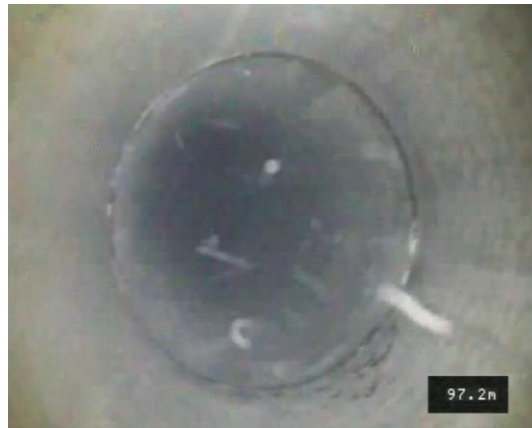
**Title 22**

Joint image

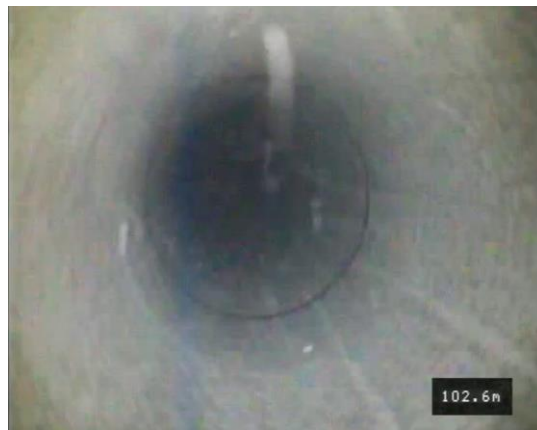
**Title 23**

Joint image

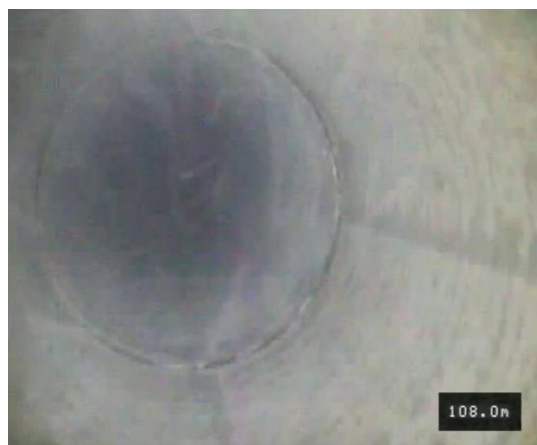
**Title 24**

Joint image

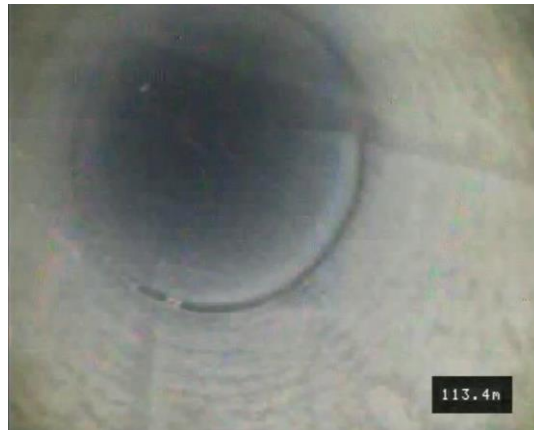
**Title 25**

Joint image

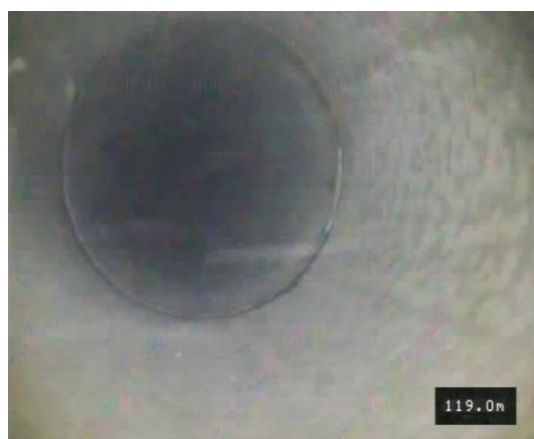
**Title 27**

Joint image

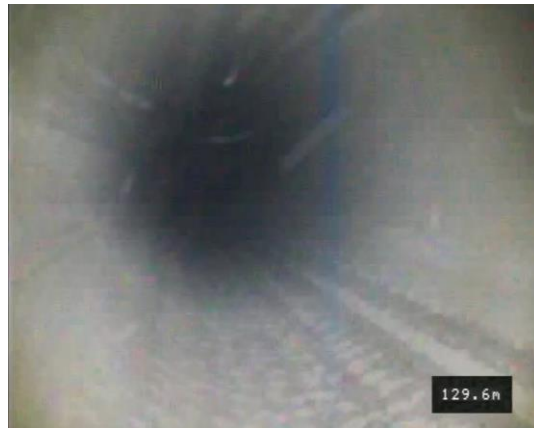
**Title 31**

Image of main

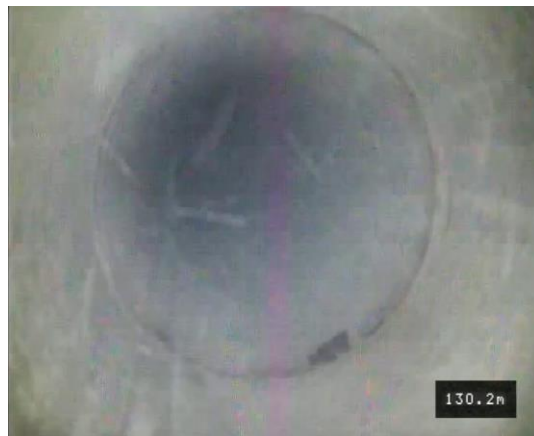
**Title 32**

Joint image

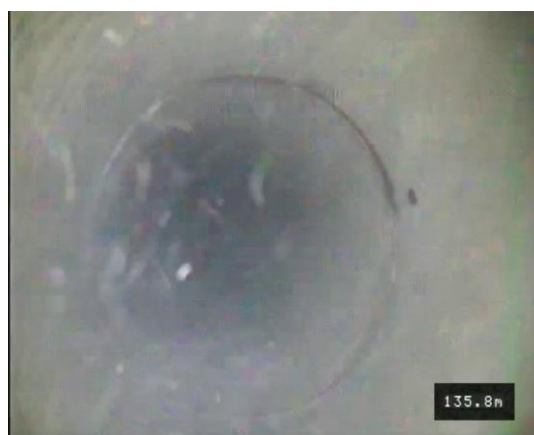
**Title 33**

Joint image

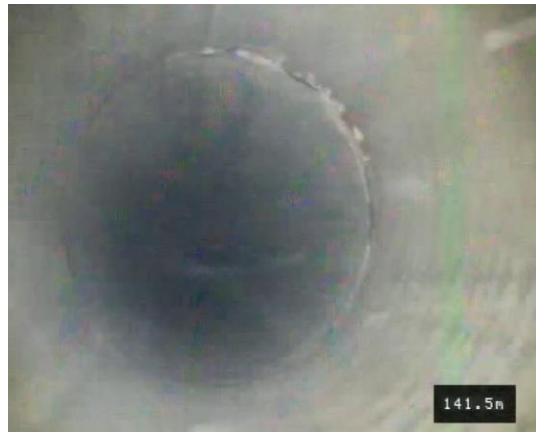
**Title 34**

Joint image

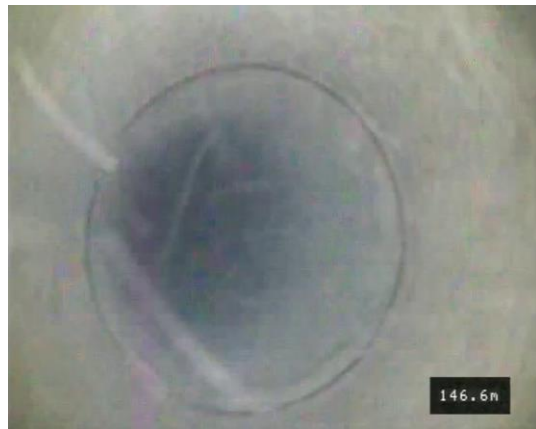
**Title 35**

Joint image

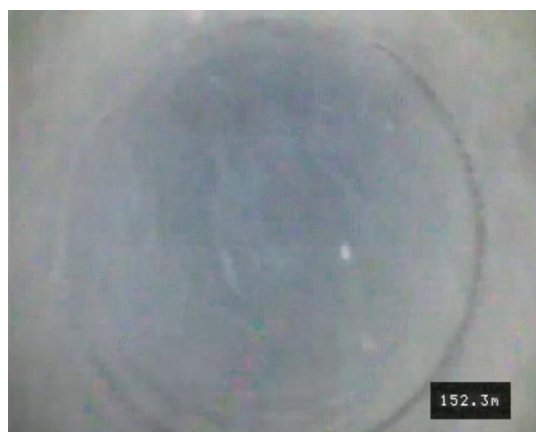
**Title 36**

Joint image

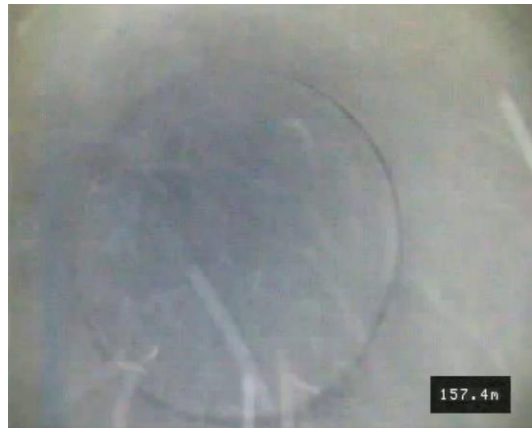
**Title 37**

Joint image

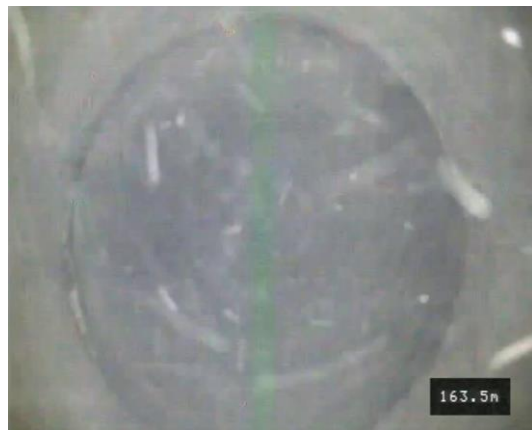
**Title 38**

Joint image

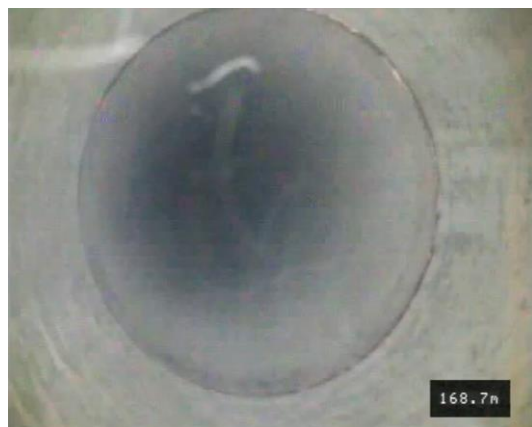
**Title 39**

Joint image

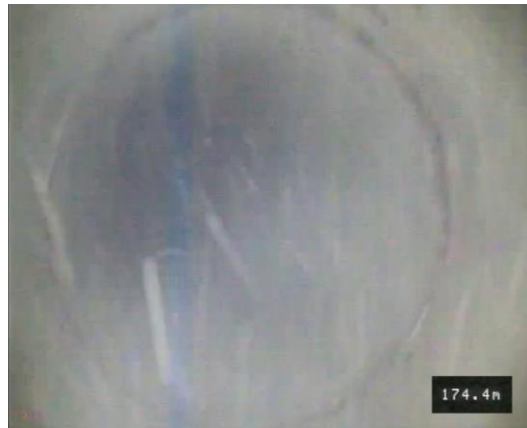
**Title 40**

Joint image

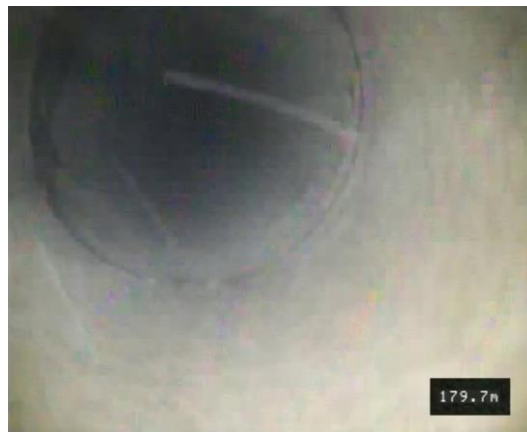
**Title 41**

Joint image

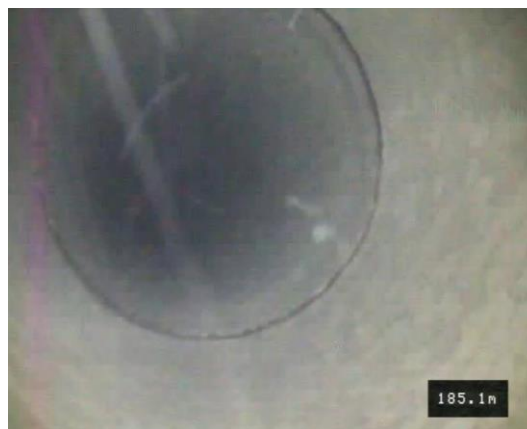
**Title 42**

Joint image

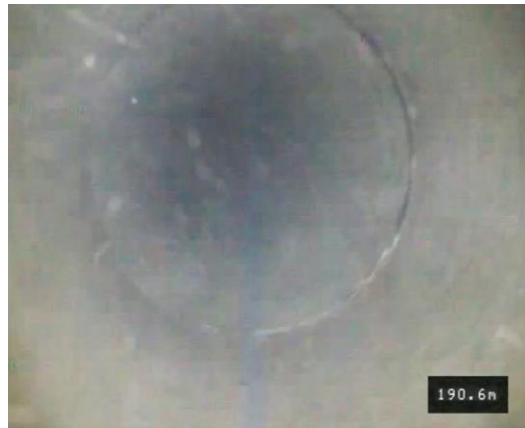
**Title 43**

Joint image

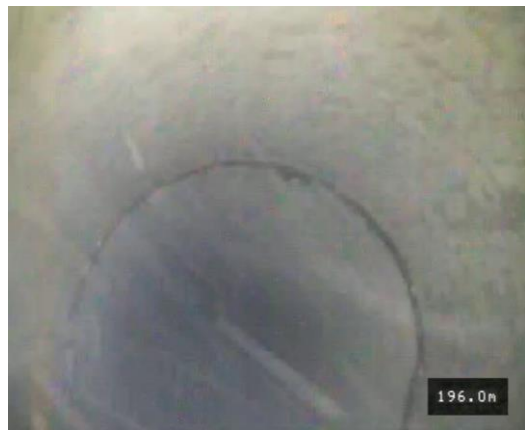
**Title 44**

Joint image

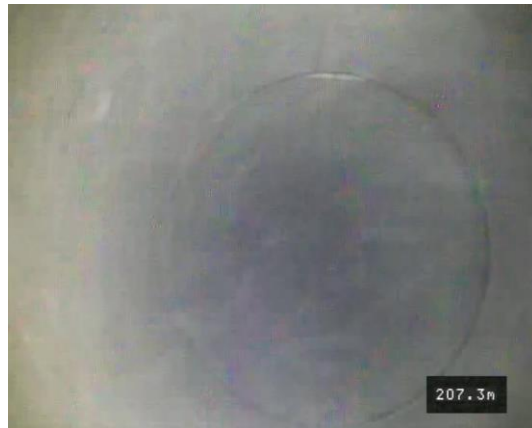
**Title 46**

Joint image

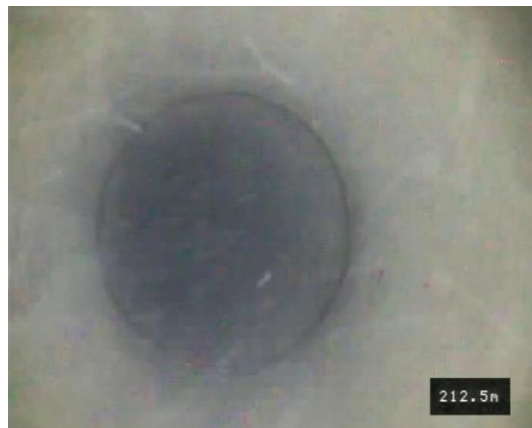
**Title 47**

Joint image

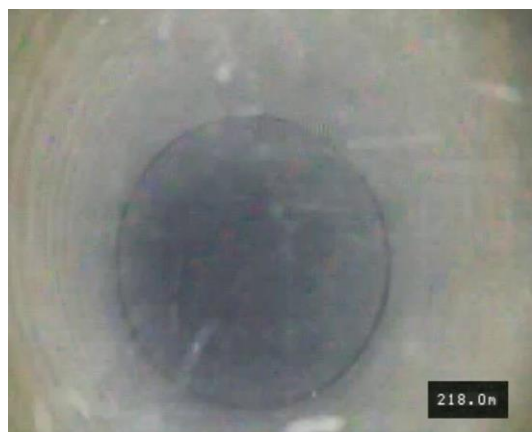
**Title 48**

Joint image

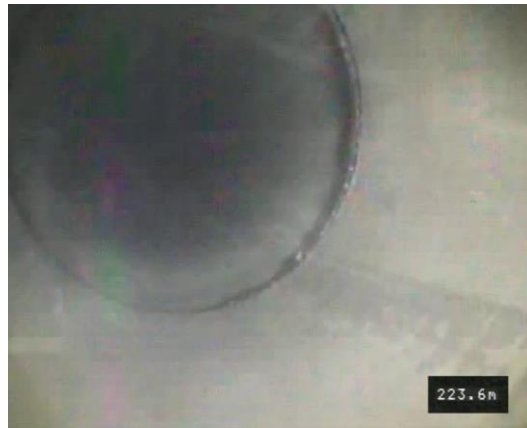
**Title 49**

Joint image

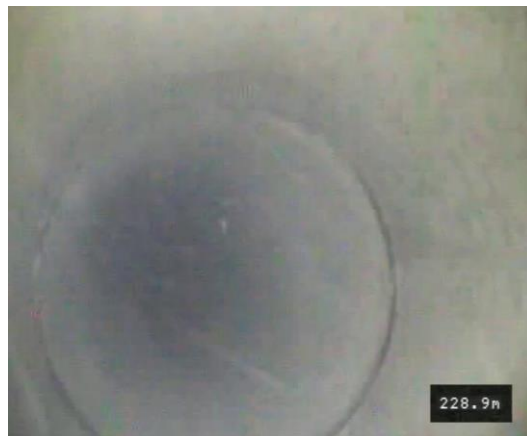
**Title 50**

Joint image

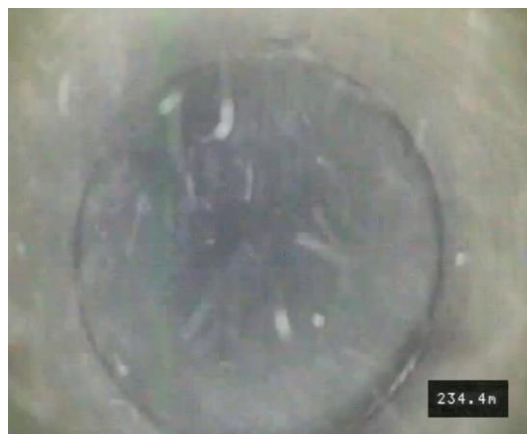
**Title 51**

Joint image

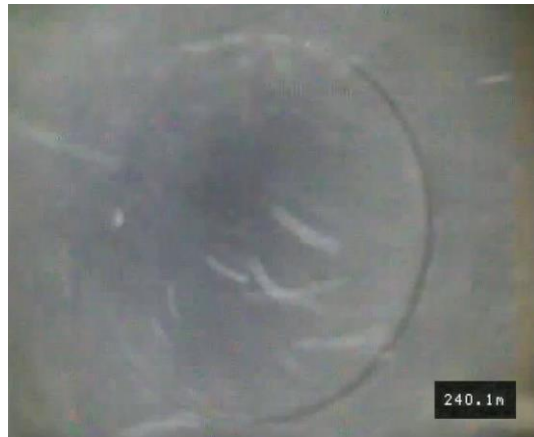
**Title 52**

Joint image

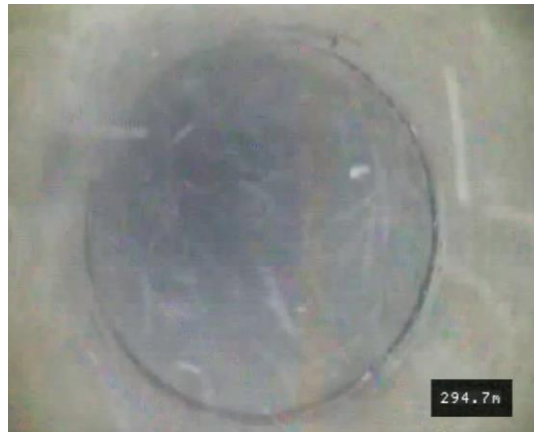
**Title 64**

Joint image

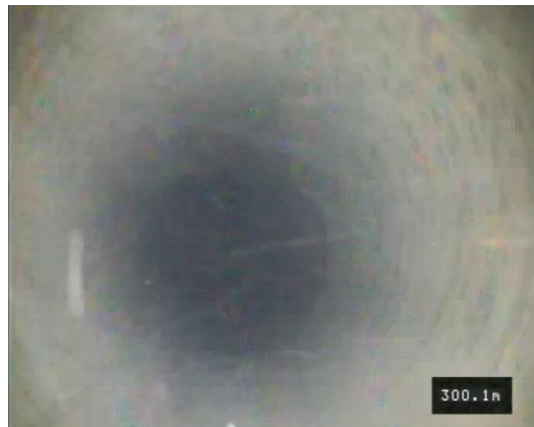
**Title 65**

Image of main

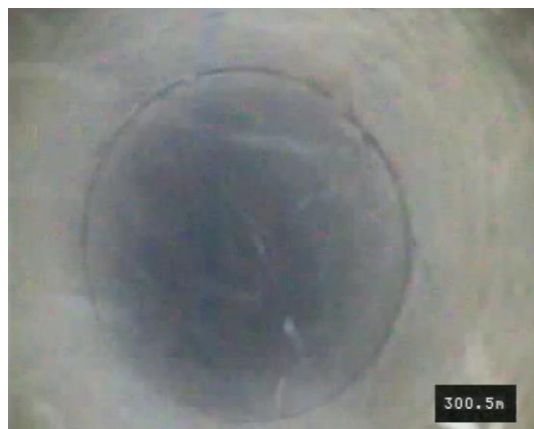
**Title 66**

Joint image

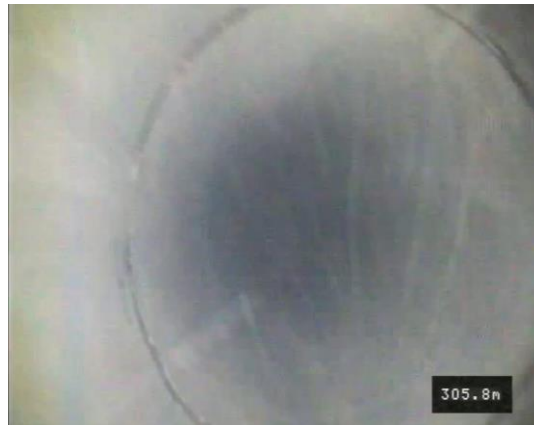
**Title 67**

Joint image

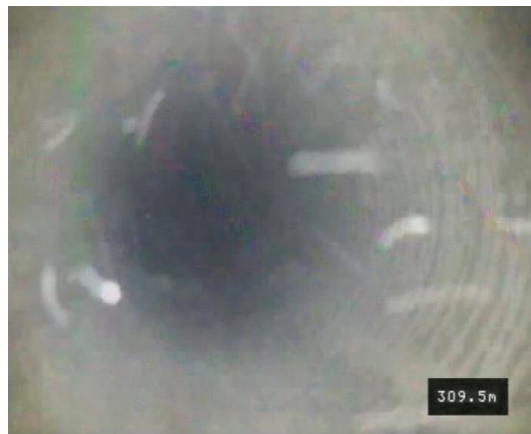
**Title 68**

Image of main

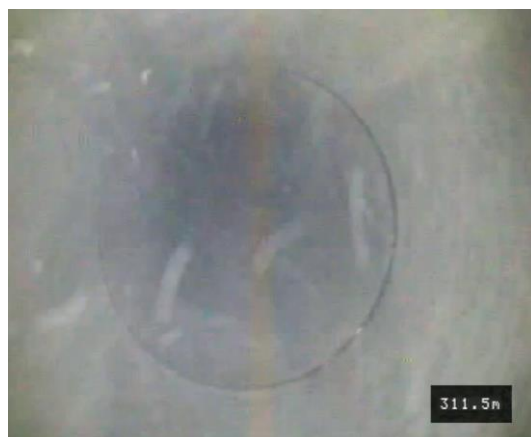
**Title 69**

Joint image

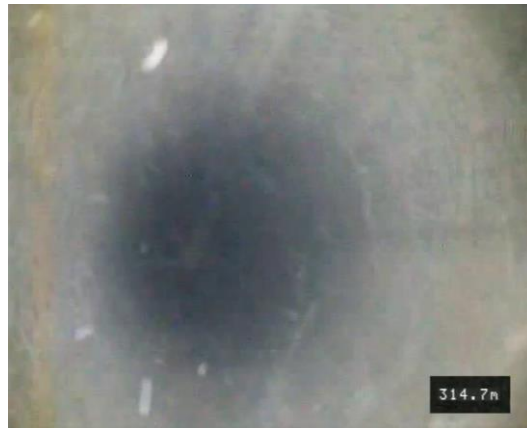
**Title 70**

Image of main

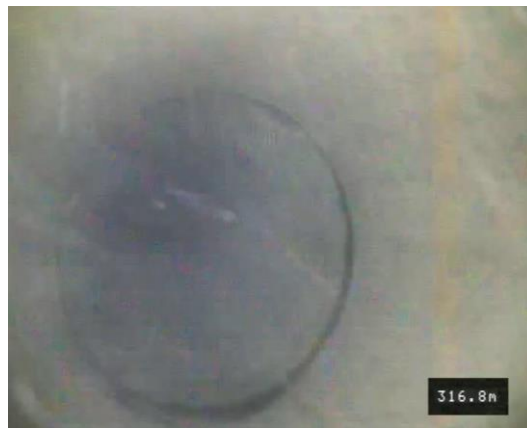
**Title 71**

Joint image

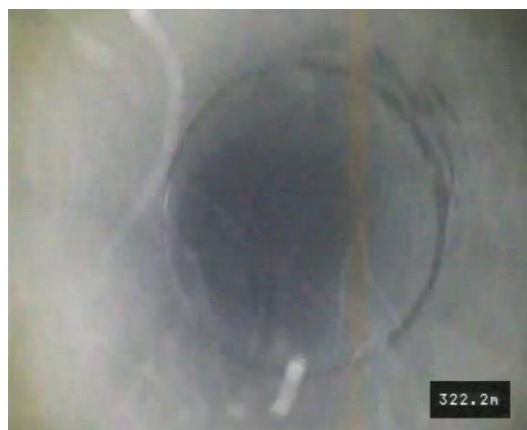
**Title 72**

Joint image

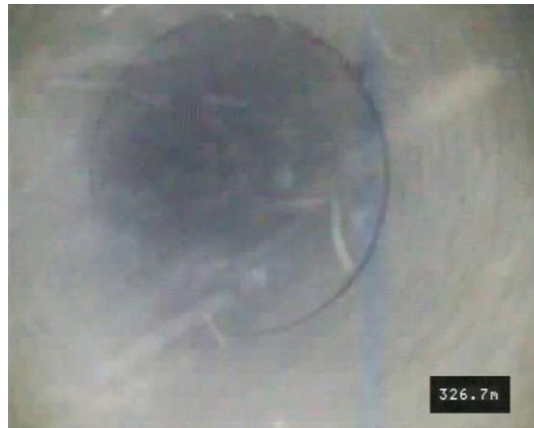
**Title 73**

Joint image

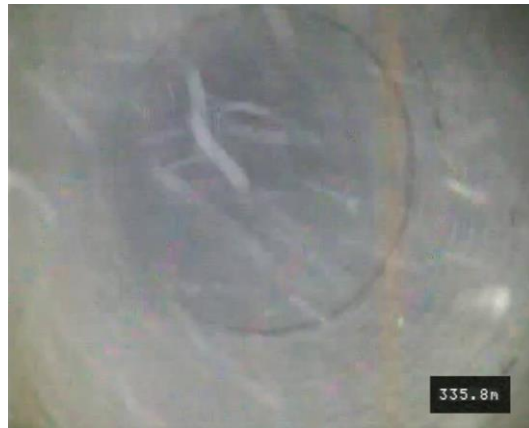
**Title 76**

Joint image

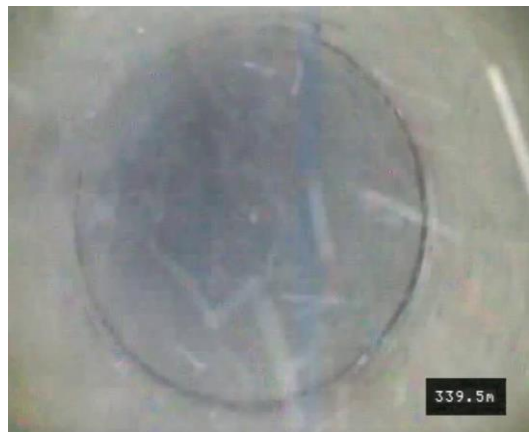
**Title 77**

Joint image

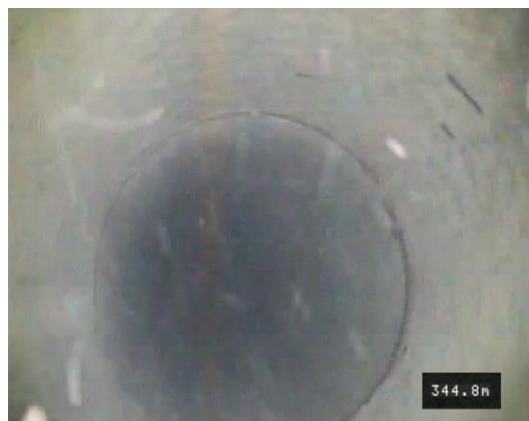
**Title 78**

Joint image

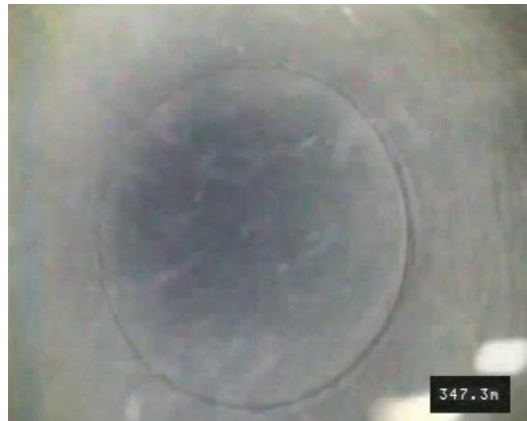
**Title 79**

Joint image

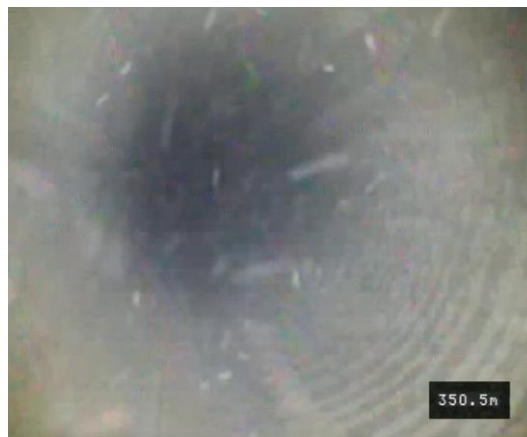
**Title 80**

Image of main

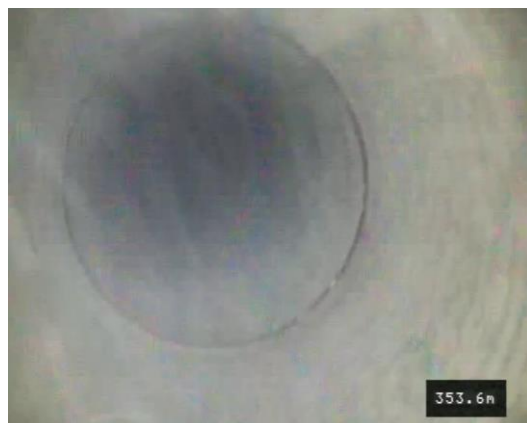
**Title 81**

Joint image

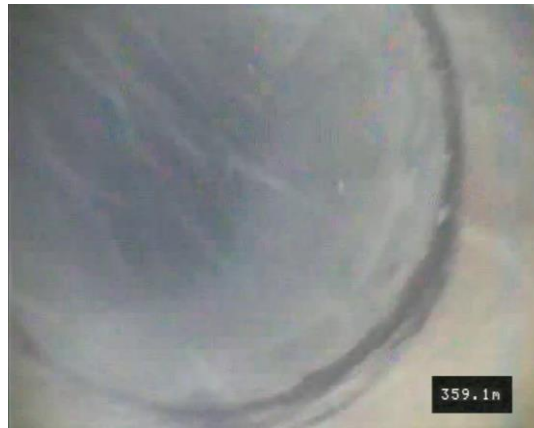
**Title 82**

Joint image

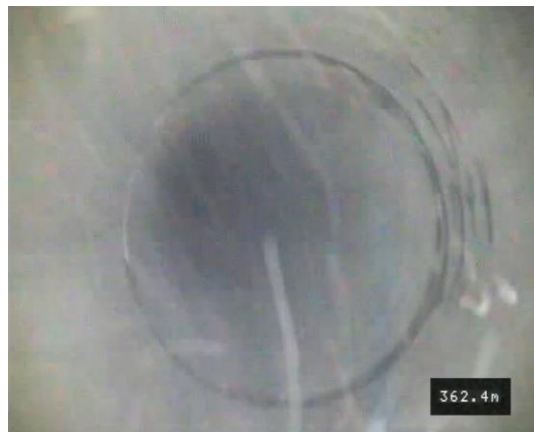
**Title 83**

Joint image

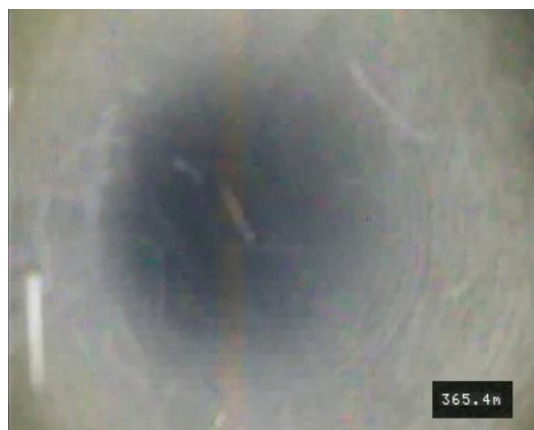
**Title 84**

Image of main

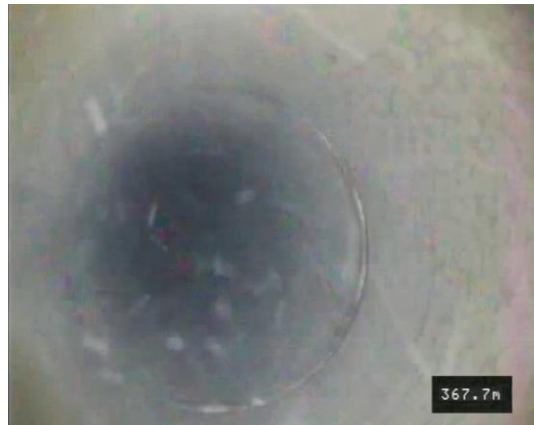
**Title 85**

Joint image

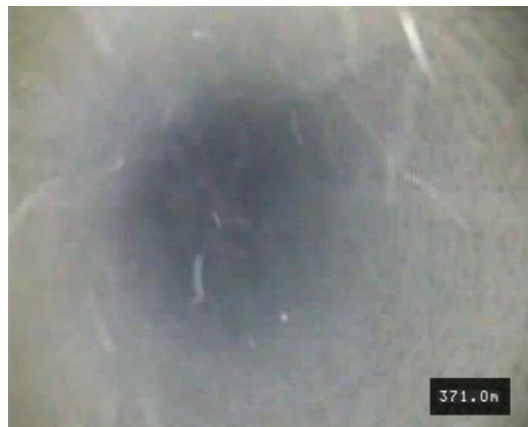
**Title 86**

Image of main

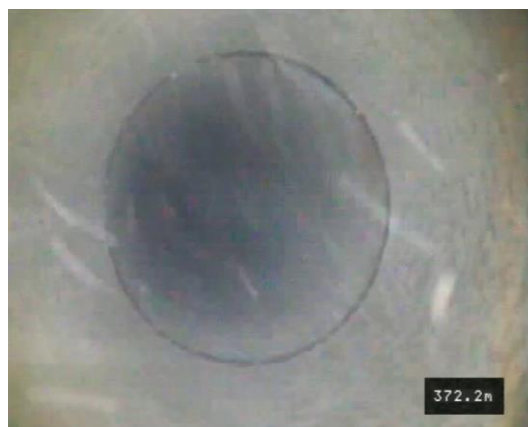
**Title 87**

Joint image

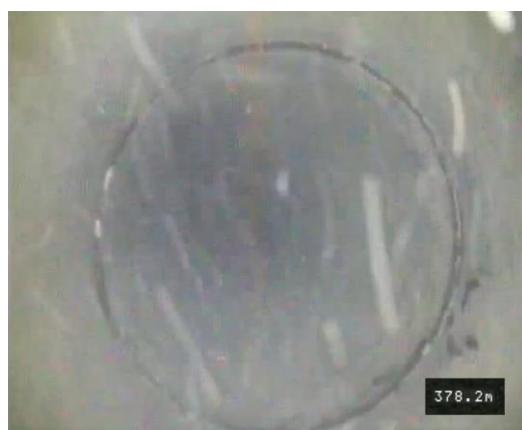
### Title 90

Joint image

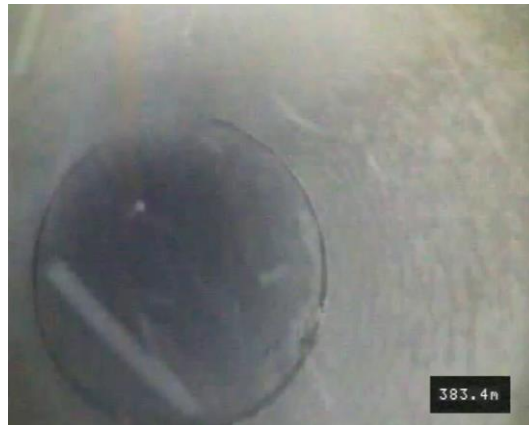
**Title 91**

Joint image

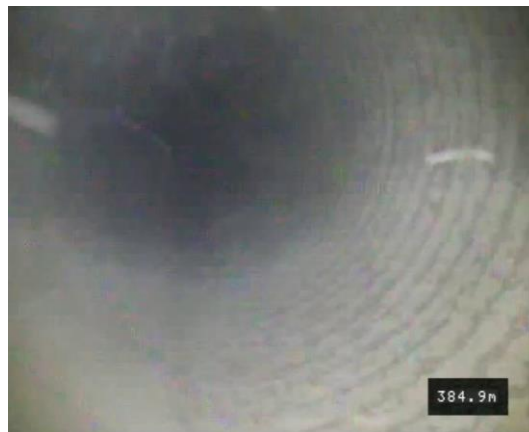
**Title 92**

Image of main

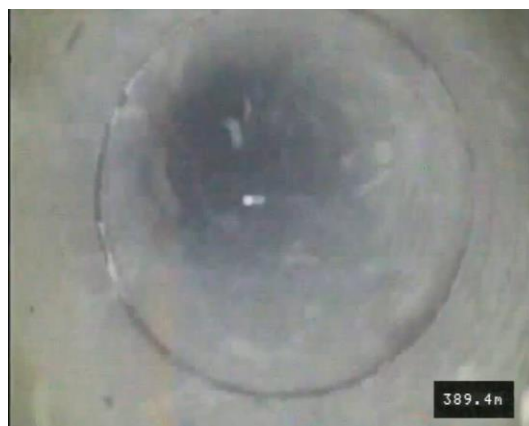
**Title 93**

Joint image

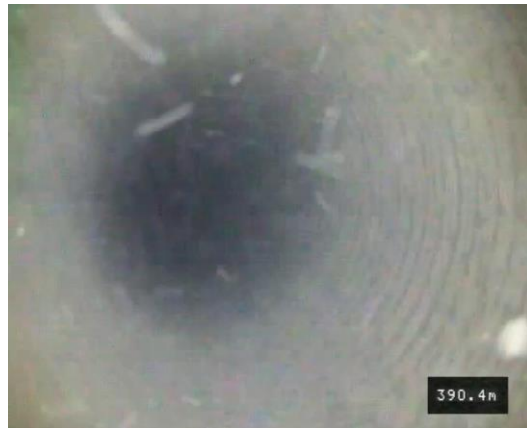
### Title 94

Image of main

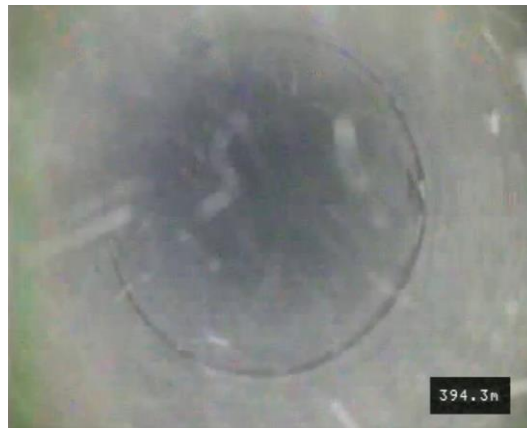
### Title 95

Joint image

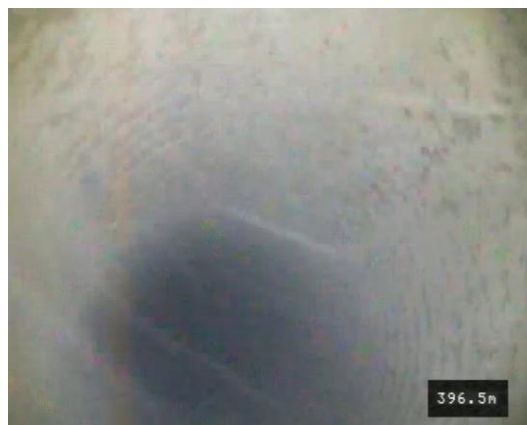
### Title 96

Image of main

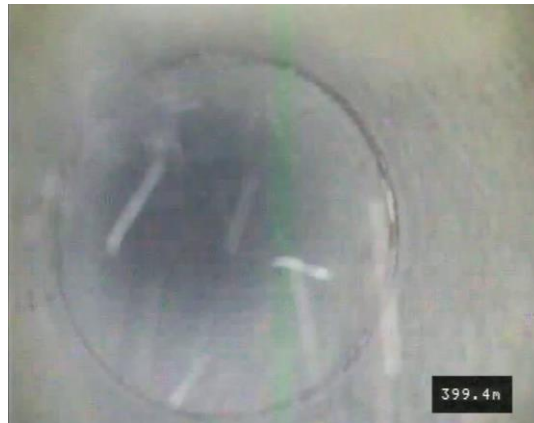
### Title 97

Joint image
